Subject: Quanta Resources Corporation Superfund Site, Operable Unit 1 (OU1), Edgewater, New Jersey, Progress Report: July 2020

This letter is the progress report required pursuant to the U.S. Environmental Protection Agency (EPA) Consent Decree for the Remedial Design (RD) and Remedial Action (RA) at the Quanta Resources Corporation Superfund Site, OU1, which was finalized with the courts on March 11, 2013.

Attachment – Figure 1 - ISS Status Map
In Situ Solidification/Stabilization Results Dashboard

JACOBS
 CIVIL
 PHASE 2 ISS CELLS

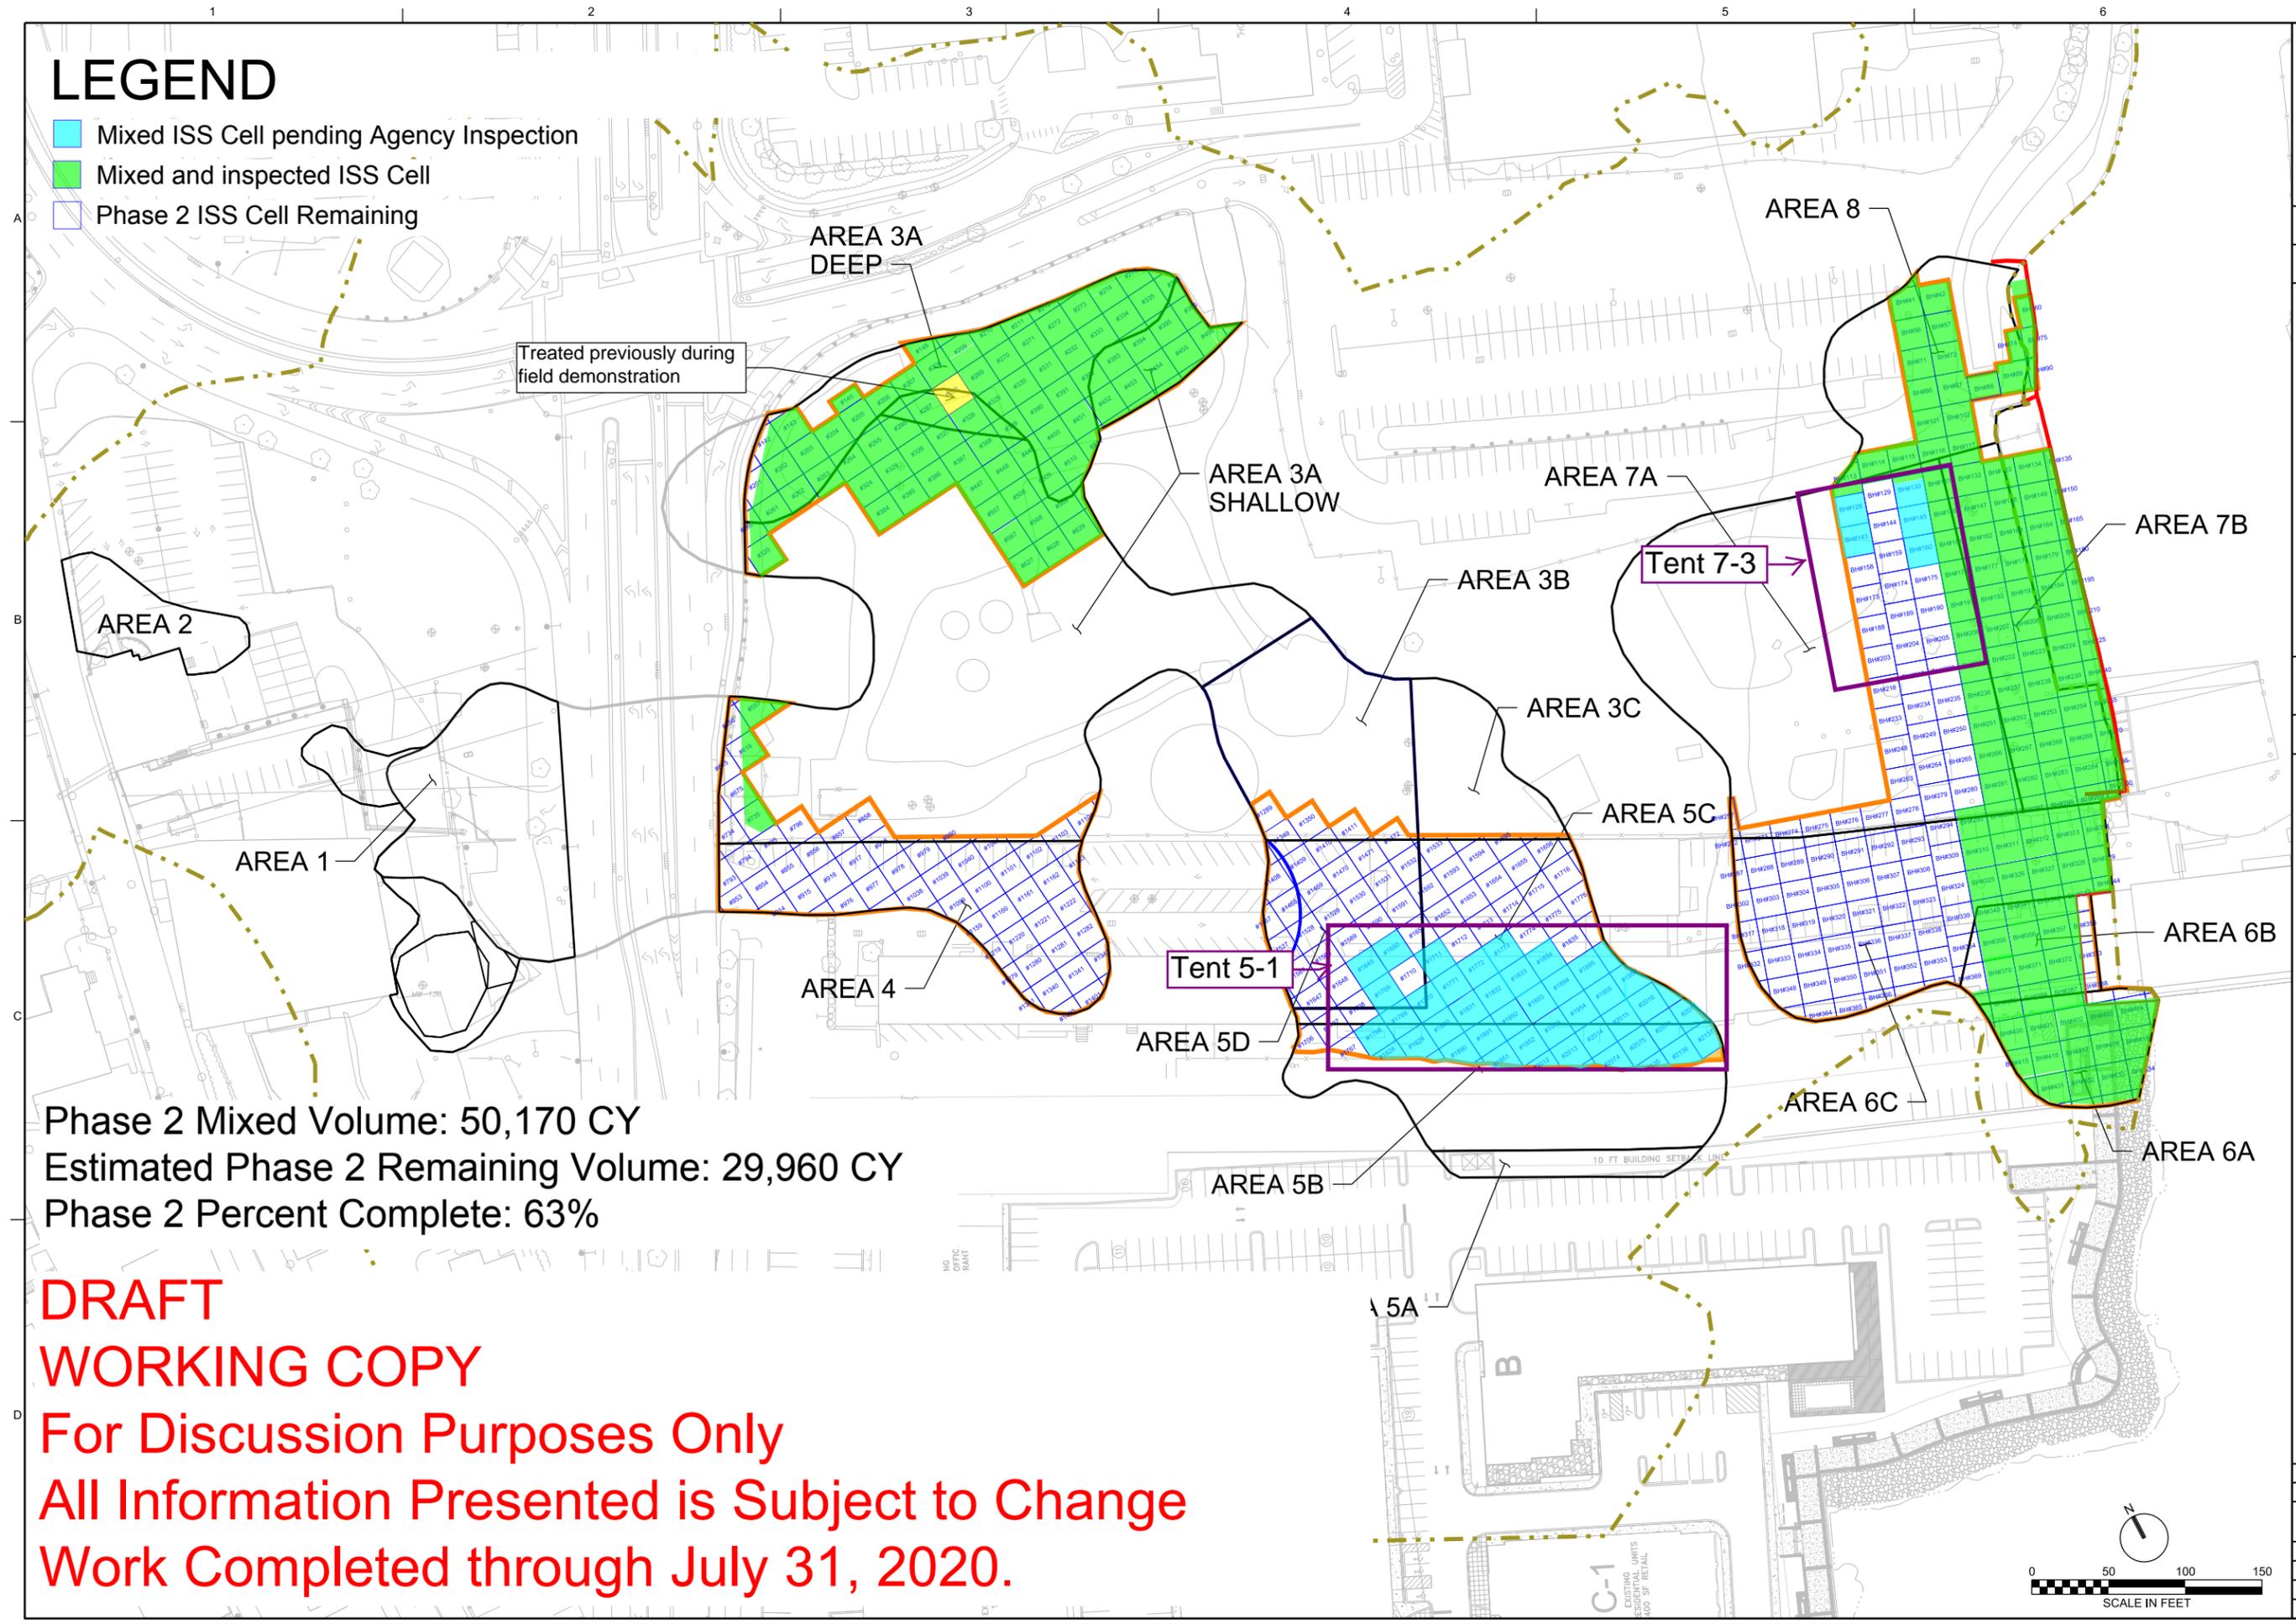
The activities completed during July to comply with the Consent Decree are described in the following subsections. Figure 1 (attached) depicts the work activities completed as of the end of July.

- Mixed ISS Cell pending Agency Inspection
- Mixed and inspected ISS Cell
- Phase 2 ISS Cell Remaining

Phase 2 Mixed Volume: 50,170 CY
 Estimated Phase 2 Remaining Volume: 29,960 CY
 Phase 2 Percent Complete: 63%

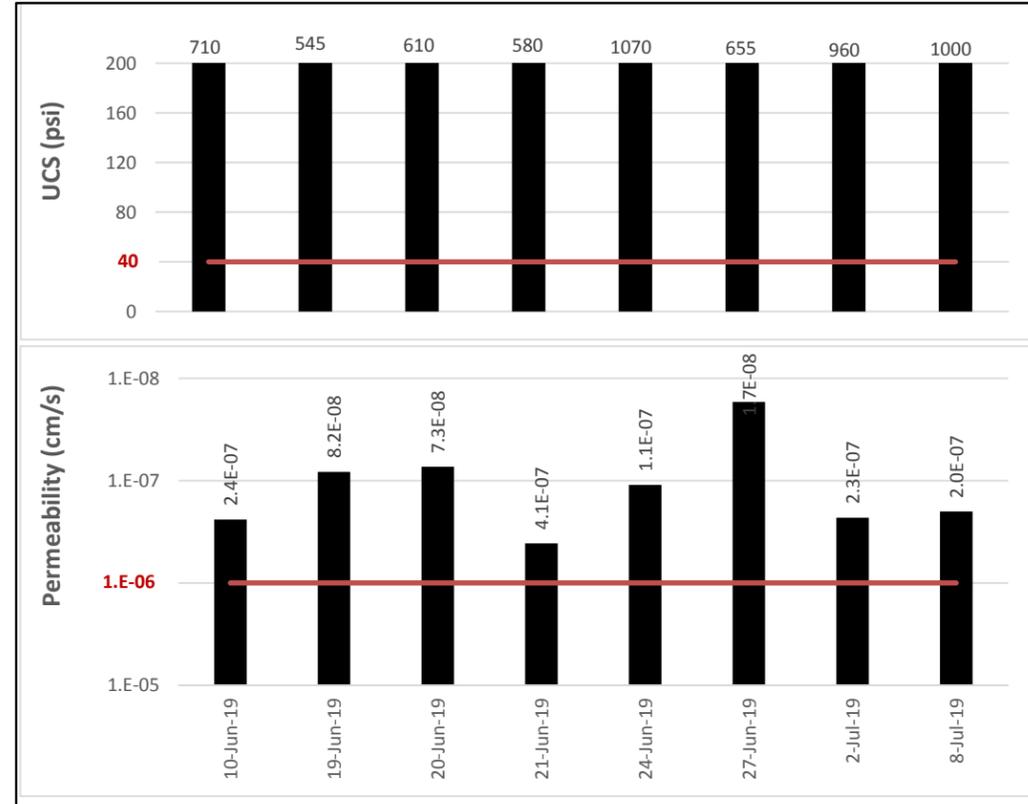
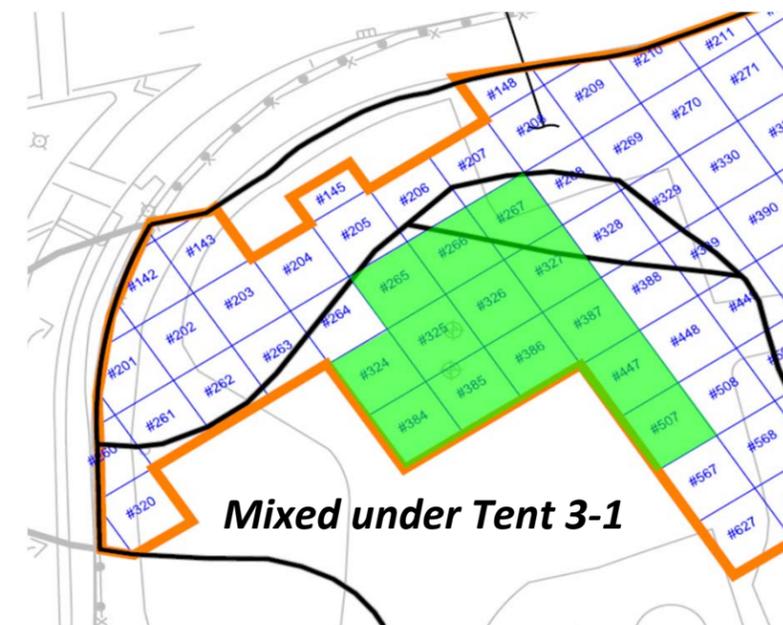
In Situ Solidification/Stabilization Results Dashboard, Tent 3-1 (Leaching Batch 5)

Tent	Date	Volume (CY)	Mix Design		UCS (≥40 psi)	Permeability (≤1E-6 cm/s)
			Cement	Slag		
3-1	10-Jun-19	288	2%	6%	710	2.40E-07
3-1	19-Jun-19	167	2%	6%	545	8.20E-08
3-1	20-Jun-19	166	2%	6%	610	7.30E-08
3-1	21-Jun-19	280	2%	6%	580	4.10E-07
3-1	24-Jun-19	147	2%	6%	1070	1.10E-07
3-1	27-Jun-19	343	2%	6%	655	1.70E-08
3-1	2-Jul-19	343	2%	6%	960	2.30E-07
3-1	8-Jul-19	342	2%	6%	1000	2.00E-07

Leaching Reduction by Constituent		
Site Constituent	8-Jul-19	
1 Arsenic	97%	
2 Benzene	99%	
3 Toluene	99%	
4 Ethylbenzene	99%	
5 Total Xylenes	99%	
6 Naphthalene	96%	
7 Acenaphthene	88%	
8 Acenaphthylene	94%	
9 Anthracene	NE	<1% tPAH
10 Benzo(a)anthracene	NE	<1% tPAH
11 Benzo(a)pyrene	NE	<1% tPAH
12 Benzo(b)fluoranthene	NE	<1% tPAH
13 Benzo(g,h,i)perylene	NE	Not detected
14 Benzo(k)fluoranthene	NE	<1% tPAH
15 Chrysene	NE	<1% tPAH
16 Dibenz(a,h)anthracene	NE	Not detected
17 Fluoranthene	NE	<1% tPAH
18 Fluorene	83%	
19 Indeno(1,2,3-cd)pyrene	NE	Not detected
20 Phenanthrene	53%	
21 Pyrene	NE	<1% tPAH
Constituents Passing	7 of 10

Note: Mixed areas awaiting EPA inspection indicated with blue shading. Green cells are mixed and have been inspected.

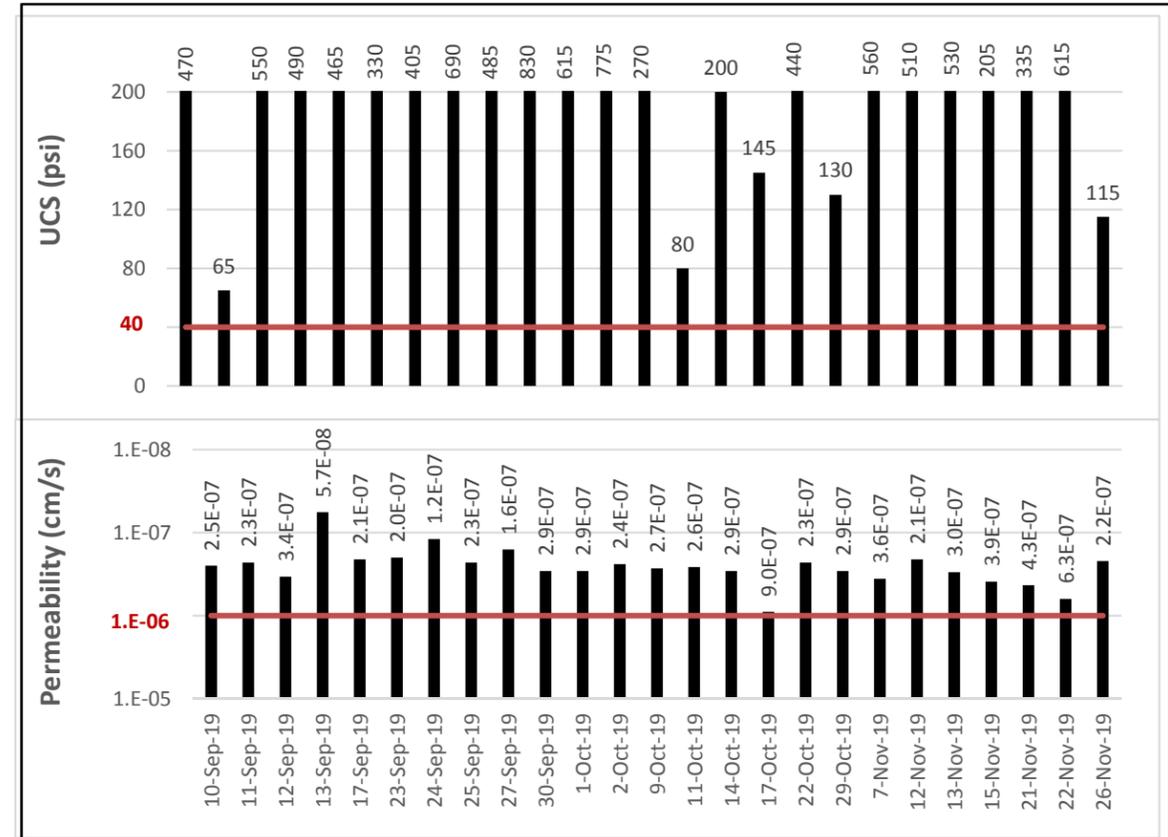
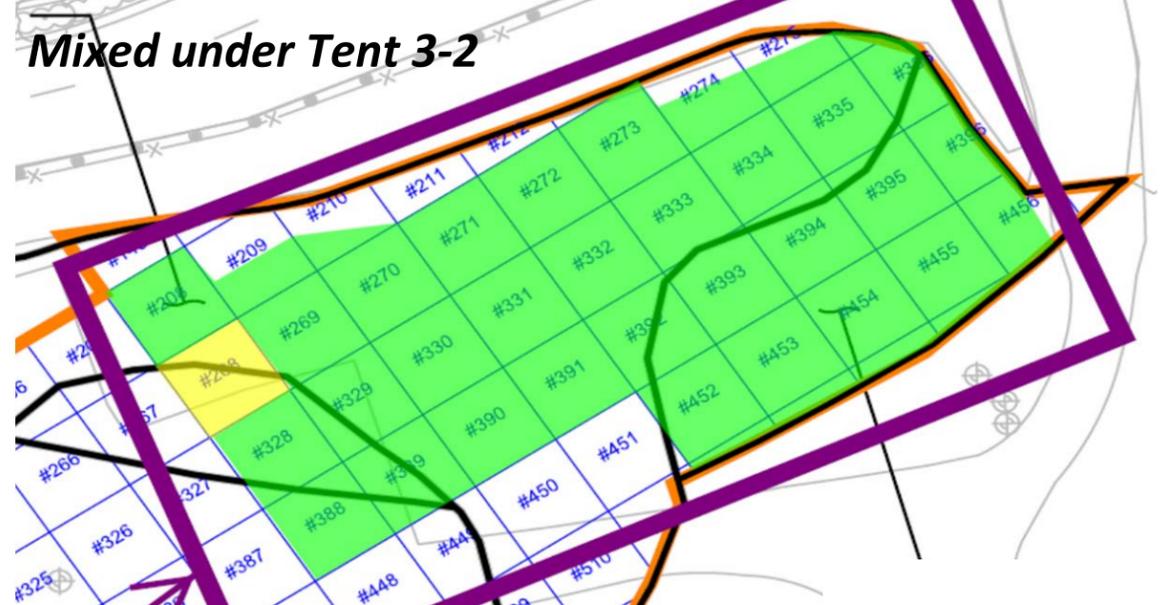
In Situ Solidification/Stabilization Results Dashboard, Tent 3-2 (Leaching Batch 5)

Tent	Date	Volume (CY)	Mix Design		UCS (≥40 psi)	Permeability (≤1E-6 cm/s)
			Cement	Slag		
3-2	10-Sep-19	179	2%	6%	470	2.50E-07
3-2	11-Sep-19	339	2%	6%	65	2.30E-07
3-2	12-Sep-19	293	2%	6%	550	3.40E-07
3-2	13-Sep-19	182	2%	6%	490	5.70E-08
3-2	17-Sep-19	343	2%	6%	465	2.10E-07
3-2	23-Sep-19	342	2%	6%	330	2.00E-07
3-2	24-Sep-19	329	2%	6%	405	1.20E-07
3-2	25-Sep-19	328	2%	6%	690	2.30E-07
3-2	27-Sep-19	414	2%	6%	485	1.60E-07
3-2	30-Sep-19	304	2%	6%	830	2.90E-07
3-2	1-Oct-19	348	2%	6%	615	2.90E-07
3-2	2-Oct-19	355	2%	6%	775	2.40E-07
3-2	9-Oct-19	306	2%	6%	270	2.70E-07
3-2	11-Oct-19	320	2%	6%	80	2.60E-07
3-2	14-Oct-19	71	2%	6%	200	2.90E-07
3-2	17-Oct-19	301	2%	6%	145	9.00E-07
3-2	22-Oct-19	320	2%	6%	440	2.30E-07
3-2	29-Oct-19	273	2%	6%	130	2.90E-07
3-2	7-Nov-19	261	2%	6%	560	3.60E-07
3-2	12-Nov-19	327	2%	6%	510	2.10E-07
3-2	13-Nov-19	104	2%	6%	530	3.00E-07
3-2	15-Nov-19	203	2%	6%	205	3.90E-07
3-2	21-Nov-19	319	2%	6%	335	4.30E-07

Extra Sample; See Tent 3-1 Dashboard for Batch 5 Leaching Results

Note: Mixed areas awaiting EPA inspection indicated with blue shading. Green cells are mixed and have been inspected. Yellow cells were previously mixed during the ISS Field Demonstration.

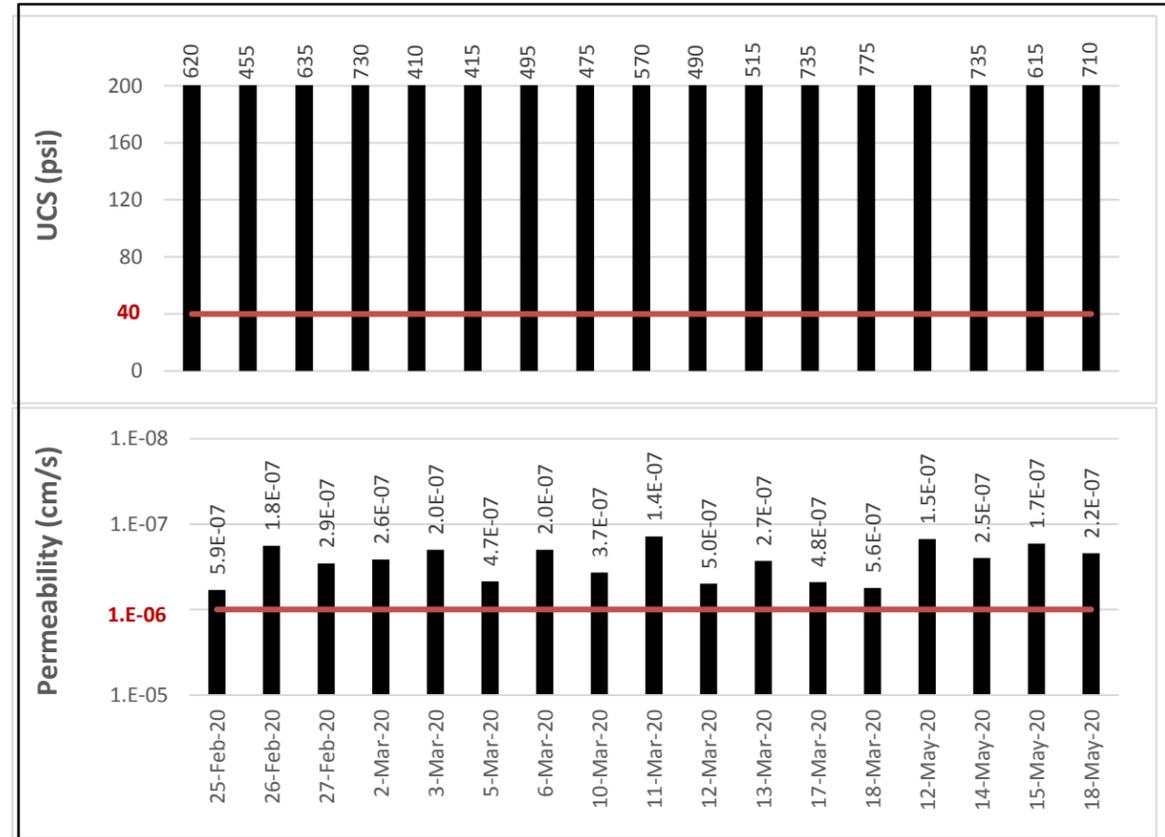
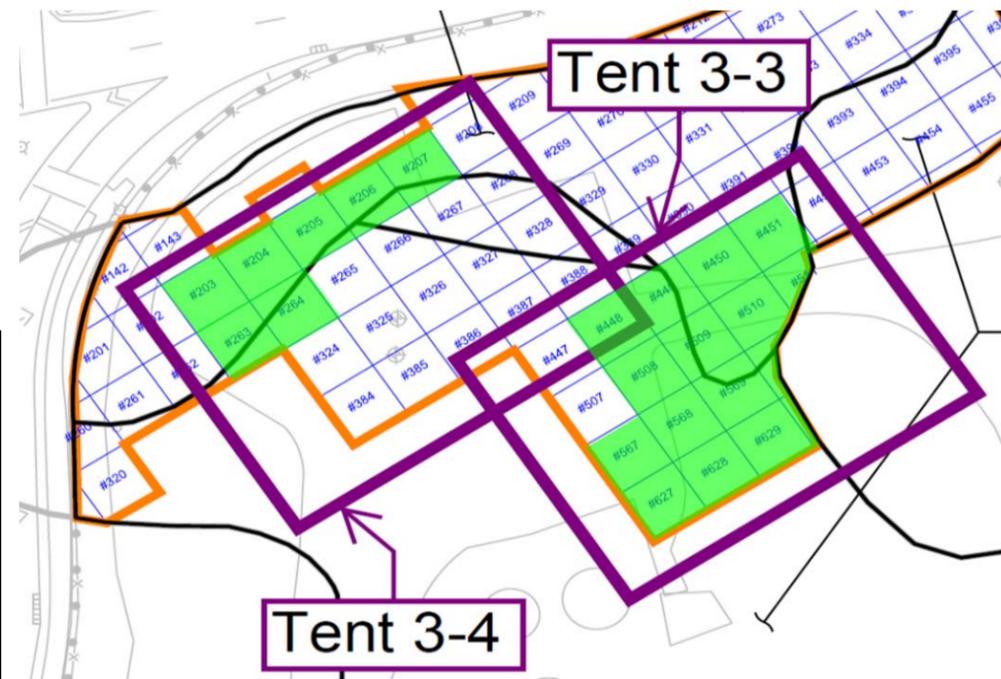
In Situ Solidification/Stabilization Results Dashboard, Tents 3-3 and 3-4 (Leaching Batch 5)

Tent	Date	Volume (CY)	Mix Design		UCS (≥40 psi)	Permeability (≤1E-6 cm/s)
			Cement	Slag		
3-3	25-Feb-20	313	2%	6%	620	5.90E-07
3-3	26-Feb-20	327	2%	6%	455	1.80E-07
3-3	27-Feb-20	173	2%	6%	635	2.90E-07
3-3	2-Mar-20	173	2%	6%	730	2.60E-07
3-3	3-Mar-20	210	2%	6%	410	2.00E-07
3-3	5-Mar-20	173	2%	6%	415	4.70E-07
3-3	6-Mar-20	36	2%	6%	495	2.00E-07
3-3	10-Mar-20	323	2%	6%	475	3.70E-07
3-3	11-Mar-20	173	2%	6%	570	1.40E-07
3-3	12-Mar-20	152	2%	6%	490	5.00E-07
3-3	13-Mar-20	173	2%	6%	515	2.70E-07
3-3	17-Mar-20	327	2%	6%	735	4.80E-07
3-3	18-Mar-20	125	2%	6%	775	5.60E-07
3-4	12-May-20	686	2%	6%	515	1.50E-07
3-4	14-May-20	610	2%	6%	735	2.50E-07
3-4	15-May-20	531	2%	6%	615	1.70E-07
3-4	18-May-20	347	2%	6%	710	2.20E-07

Leaching Sample on February 27 Held; See Tent 3-1 Dashboard for Batch 5 Leaching

Note: Mixed areas awaiting EPA inspection indicated with blue shading. Green cells are mixed and have been inspected. Yellow cells were previously mixed during the ISS Field Demonstration.

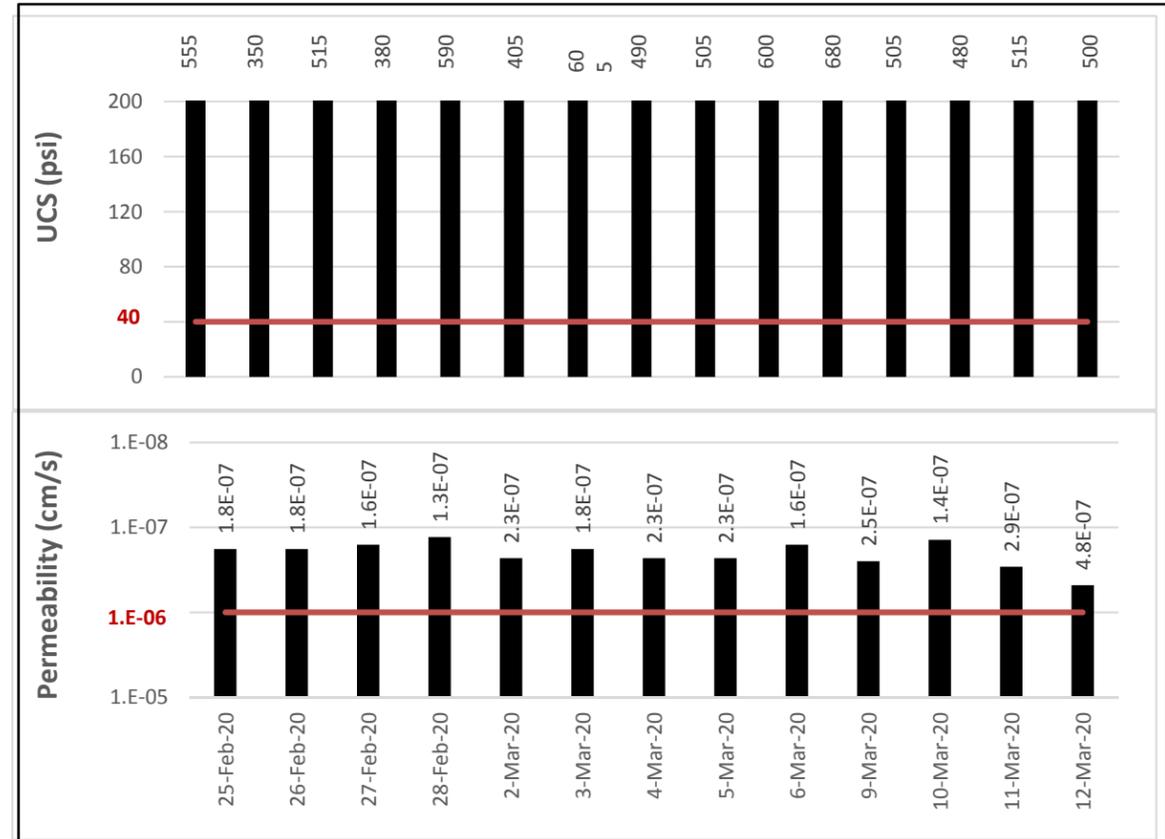
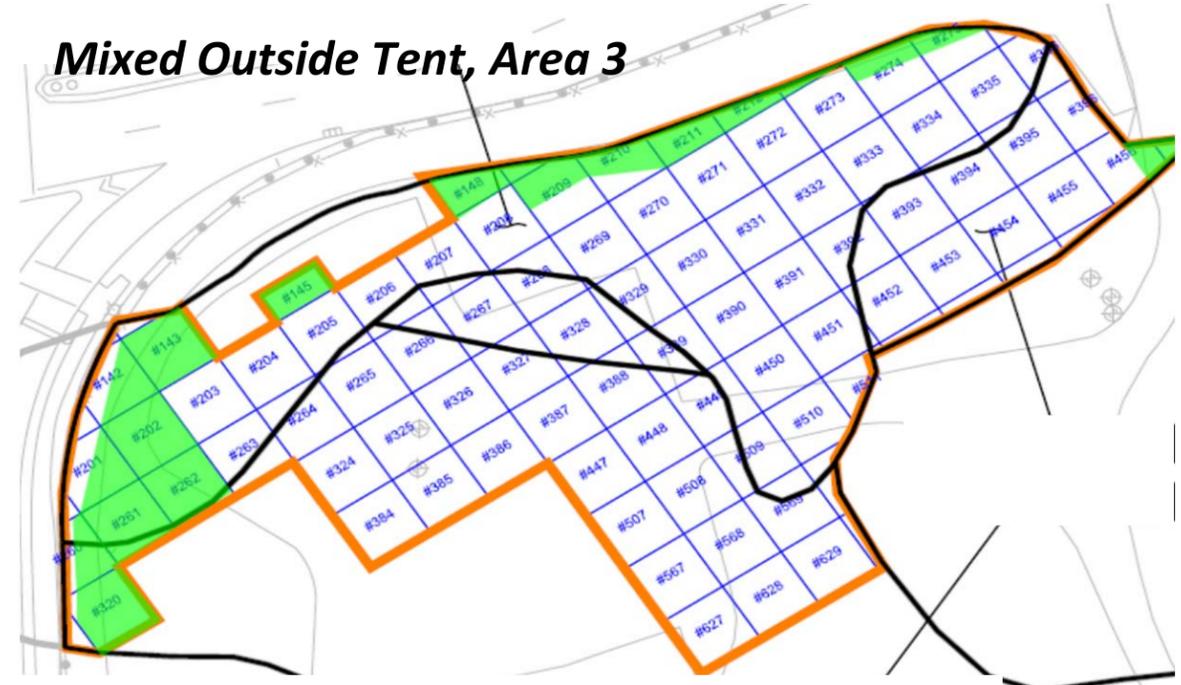
In Situ Solidification/Stabilization Results Dashboard, NT-31, 32, 33 (Leaching Batch 5)

Area	Date	Volume (CY)	Mix Design		UCS (≥40 psi)	Permeability (≤1E-6 cm/s)
			Cement	Slag		
NT-33	25-Feb-20	39	2%	6%	555	1.80E-07
NT-32	26-Feb-20	131	2%	6%	350	1.80E-07
NT-32	27-Feb-20	269	2%	6%	515	1.60E-07
NT-32	28-Feb-20	258	2%	6%	380	1.30E-07
NT-32	2-Mar-20	291	2%	6%	590	2.30E-07
NT-32	3-Mar-20	66	2%	6%	405	1.80E-07
NT-31	4-Mar-20	367	2%	6%	605	2.30E-07
NT-31	5-Mar-20	166	2%	6%	490	2.30E-07
NT-31	6-Mar-20	167	2%	6%	505	1.60E-07
NT-31	9-Mar-20	151	2%	6%	600	2.50E-07
NT-31	10-Mar-20	333	2%	6%	680	1.40E-07
NT-31	11-Mar-20	167	2%	6%	505	2.90E-07
NT-31	12-Mar-20	303	2%	6%	480	4.80E-07
NT-31	17-Mar-20	173	2%	6%	515	9.10E-07
NT-31	24-Mar-20	333	2%	6%	500	2.10E-07

Sample on March 10 Held; See Tent 3-1 Dashboard for Batch 5 Leaching Results

Note: Mixed areas awaiting EPA inspection indicated with blue shading. Green cells are mixed and have been inspected. Yellow cells were previously mixed during the ISS Field Demonstration.

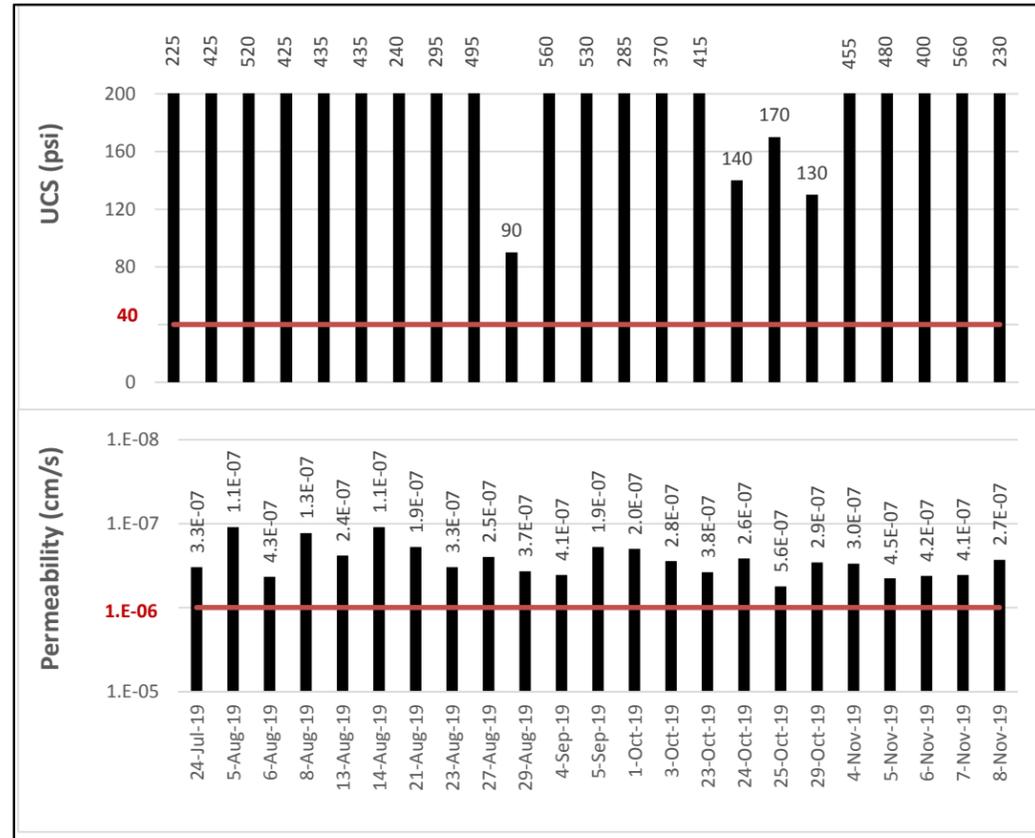
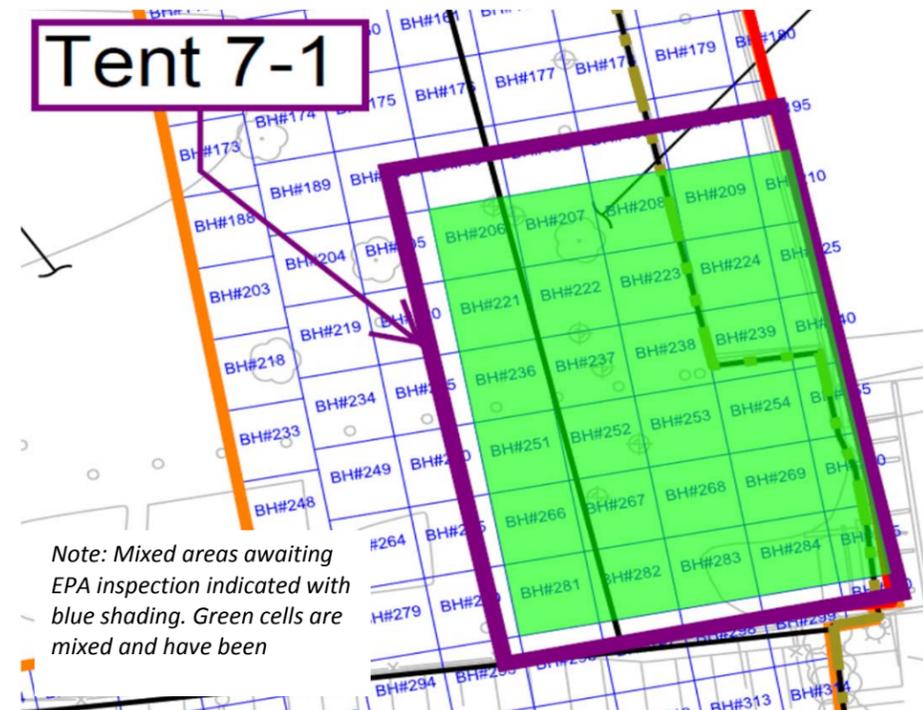
In Situ Solidification/Stabilization Results Dashboard, Tent 7-1 (Leaching Batch 6)

Tent	Date	Volume (CY)	Mix Design		UCS (≥40 psi)	Permeability (≤1E-6 cm/s)
			Cement	Slag		
7-1	24-Jul-19	536	2%	6%	225	3.3E-07
7-1	5-Aug-19	494	2%	6%	425	1.1E-07
7-1	6-Aug-19	488	2%	6%	520	4.3E-07
7-1	8-Aug-19	468	2%	6%	425	1.3E-07
7-1	13-Aug-19	502	2%	6%	435	2.4E-07
7-1	14-Aug-19	524	2%	6%	435	1.1E-07
7-1	21-Aug-19	354	2%	6%	240	1.9E-07
7-1	23-Aug-19	323	2%	6%	295	3.3E-07
7-1	27-Aug-19	291	2%	6%	495	2.5E-07
7-1	29-Aug-19	298	2%	6%	90	3.7E-07
7-1	4-Sep-19	335	2%	6%	560	4.1E-07
7-1	5-Sep-19	282	2%	6%	530	1.9E-07
7-1	1-Oct-19	457	2%	6%	285	2.0E-07
7-1	3-Oct-19	246	2%	6%	370	2.8E-07
7-1	23-Oct-19	596	2%	6%	415	3.8E-07
7-1	24-Oct-19	290	2%	6%	140	2.6E-07
7-1	25-Oct-19	308	2%	6%	170	5.6E-07
7-1	29-Oct-19	296	2%	6%	130	2.9E-07
7-1	4-Nov-19	260	2%	6%	455	3.0E-07
7-1	5-Nov-19	268	2%	6%	480	4.5E-07
7-1	6-Nov-19	159	2%	6%	400	4.2E-07
7-1	7-Nov-19	262	2%	6%	560	4.1E-07
7-1	8-Nov-19	276	2%	6%	230	2.7E-07

Leaching Reduction by Constituent		8-Aug-19	23-Oct-19
1	Arsenic	100%	HELD SAMPLE; See August 8 results for Batch 6
2	Benzene	100%	
3	Toluene	100%	
4	Ethylbenzene	98%	
5	Total Xylenes	97%	
6	Naphthalene	99%	
7	Acenaphthene	NE; <1% tPAH	
8	Acenaphthylene	NE; <1% tPAH	
9	Anthracene	NE; <1% tPAH	
10	Benzo(a)anthracene	NE; <1% tPAH	
11	Benzo(a)pyrene	NE; <1% tPAH	
12	Benzo(b)fluoranthene	NE; <1% tPAH	
13	Benzo(g,h,i)perylene	NE; not detected	
14	Benzo(k)fluoranthene	NE; not detected	
15	Chrysene	NE; <1% tPAH	
16	Dibenz(a,h)anthracene	NE; not detected	
17	Fluoranthene	NE; <1% tPAH	
18	Fluorene	NE; <1% tPAH	
19	Indeno(1,2,3-cd)pyrene	NE; not detected	
20	Phenanthrene	NE; <1% tPAH	
21	Pyrene	NE; <1% tPAH	
Constituents Passing		6 of 6

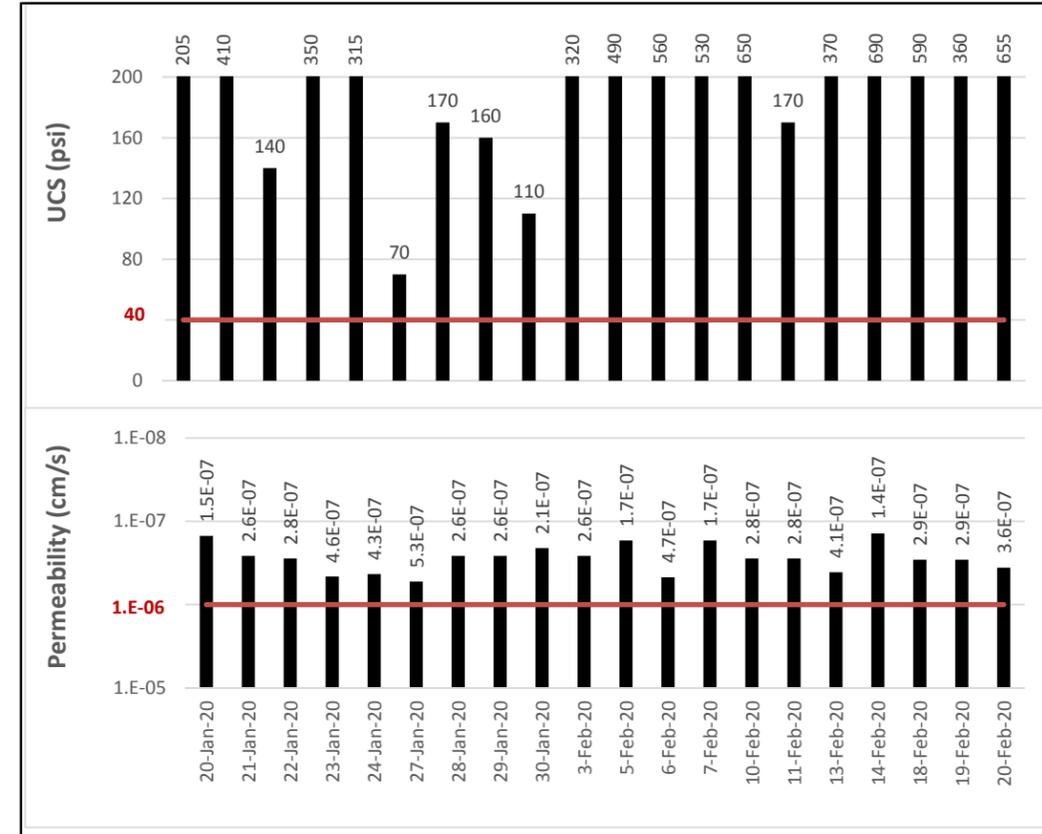
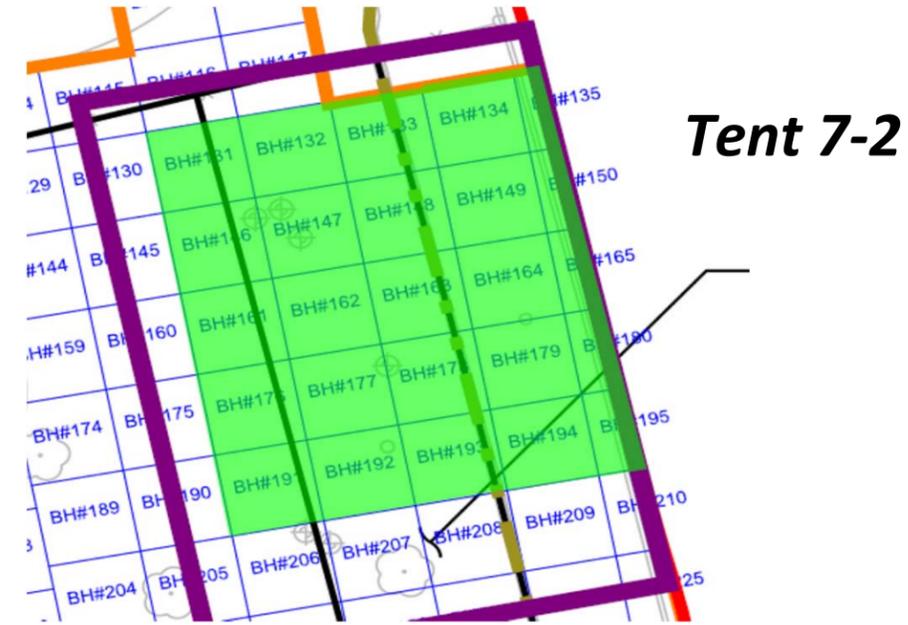
In Situ Solidification/Stabilization Results Dashboard, Tent 7-2 (Leaching Batch 6)

Tent	Date	Volume (CY)	Mix Design		UCS (≥40 psi)	Permeability (≤1E-6 cm/s)
			Cement	Slag		
7-2	20-Jan-20	312	4%	6%	205	1.5E-07
7-2	21-Jan-20	472	4%	6%	410	2.6E-07
7-2	22-Jan-20	564	4%	6%	140	2.8E-07
7-2	23-Jan-20	394	4%	6%	350	4.6E-07
7-2	24-Jan-20	538	4%	6%	315	4.3E-07
7-2	27-Jan-20	256	4%	6%	70	5.3E-07
7-2	28-Jan-20	295	4%	6%	170	2.6E-07
7-2	29-Jan-20	242	4%	6%	160	2.6E-07
7-2	30-Jan-20	329	4%	6%	110	2.1E-07
7-2	3-Feb-20	252	4%	6%	320	2.6E-07
7-2	5-Feb-20	198	4%	6%	490	1.7E-07
7-2	6-Feb-20	247	4%	6%	560	4.7E-07
7-2	7-Feb-20	249	4%	6%	530	1.7E-07
7-2	10-Feb-20	258	4%	6%	650	2.8E-07
7-2	11-Feb-20	239	4%	6%	170	2.8E-07
7-2	13-Feb-20	198	4%	6%	370	4.1E-07
7-2	14-Feb-20	214	4%	6%	690	1.4E-07
7-2	18-Feb-20	204	4%	6%	590	2.9E-07
7-2	19-Feb-20	237	4%	6%	360	2.9E-07
7-2	20-Feb-20	185	4%	6%	655	3.6E-07

Held Sample, See Tent 7-1 Dashboard for Batch 6 Results

Note: Mixed areas awaiting EPA inspection indicated with blue shading. Green cells are mixed and have been inspected.

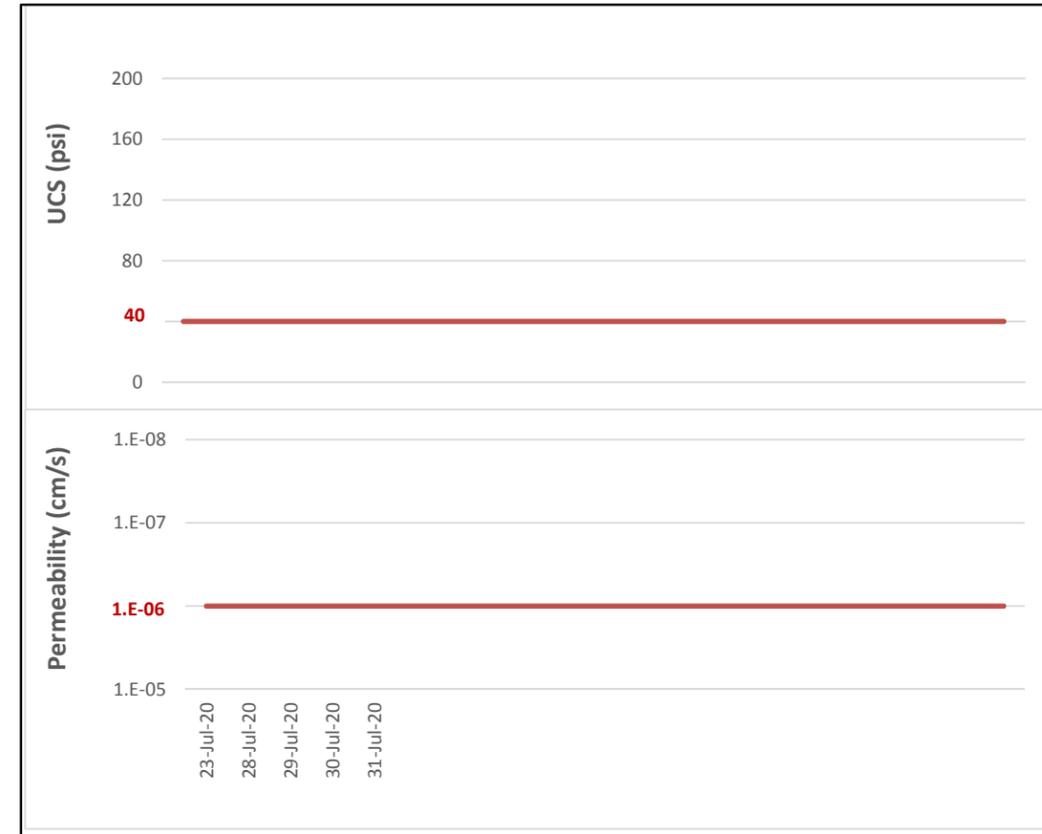
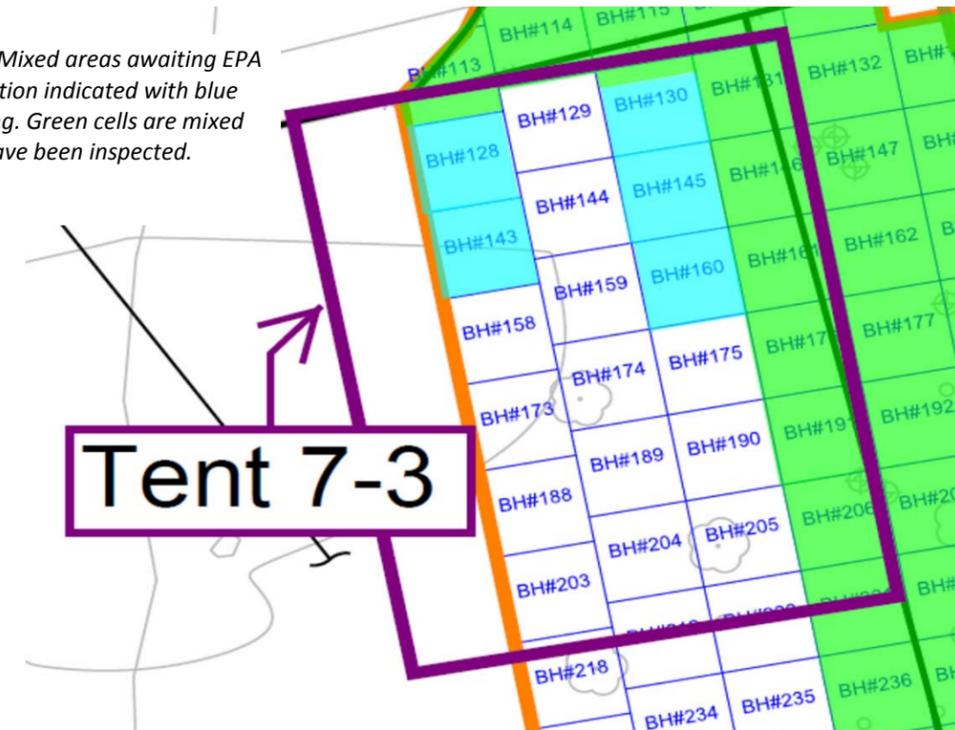
In Situ Solidification/Stabilization Results Dashboard, Tent 7-3 (Leaching Batch 6)

Tent	Date	Volume (CY)	Mix Design		UCS (≥40 psi)	Permeability (≤1E-6 cm/s)
			Cement	Slag		
7-3	23-Jul-20	182	2%	6%		
7-3	28-Jul-20	181	2%	6%		
7-3	29-Jul-20	234	2%	6%		
7-3	30-Jul-20	179	2%	6%		
7-3	31-Jul-20	251	2%	6%

Held Sample, See Tent 7-1 Dashboard for Batch 6 Results

Note: Mixed areas awaiting EPA inspection indicated with blue shading. Green cells are mixed and have been inspected.

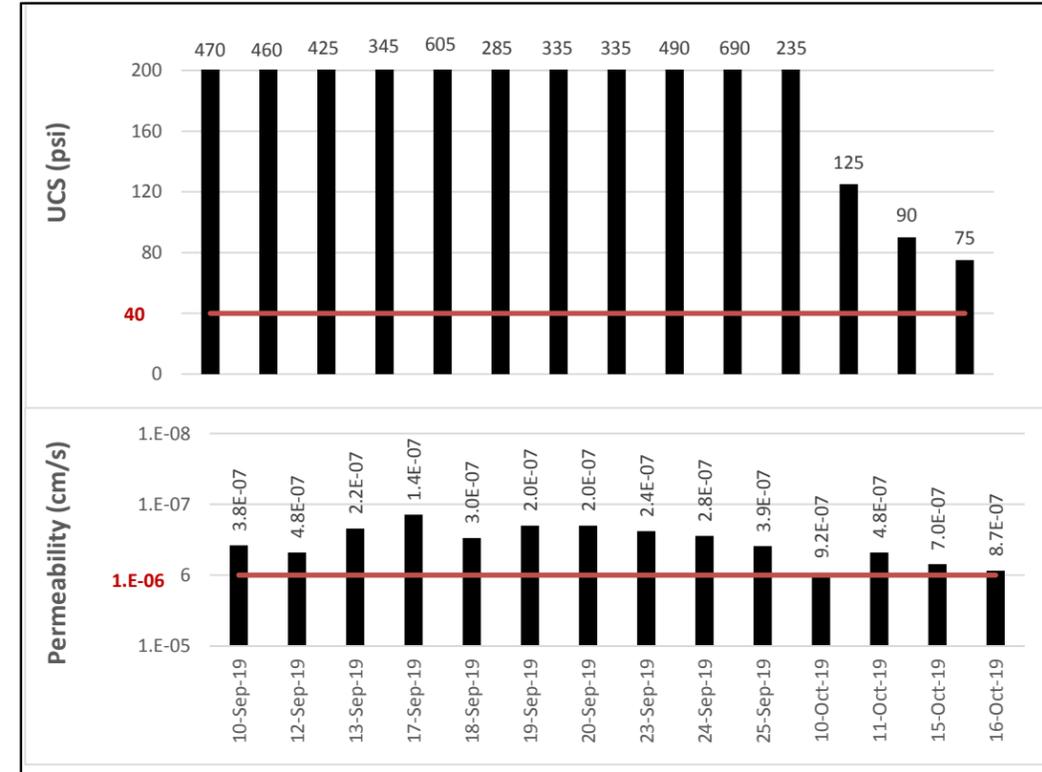
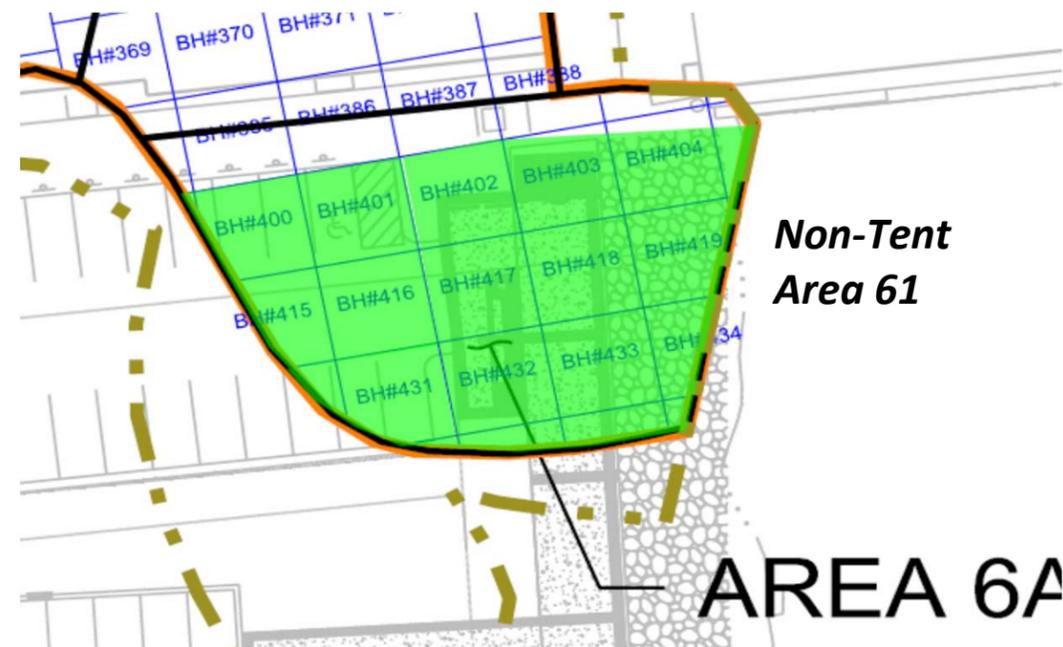
In Situ Solidification/Stabilization Results Dashboard, NT-61 (Leaching Batch 7)

Area	Date	Volume (CY)	Mix Design		UCS (≥40 psi)	Permeability (≤1E-6 cm/s)
			Cement	Slag		
NT-61	10-Sep-19	237	4%	6%	470	3.8E-07
NT-61	12-Sep-19	247	4%	6%	460	4.8E-07
NT-61	13-Sep-19	220	4%	6%	425	2.2E-07
NT-61	17-Sep-19	292	4%	6%	345	1.4E-07
NT-61	18-Sep-19	266	4%	6%	605	3.0E-07
NT-61	19-Sep-19	354	4%	6%	285	2.0E-07
NT-61	20-Sep-19	239	4%	6%	335	2.0E-07
NT-61	23-Sep-19	244	4%	6%	335	2.4E-07
NT-61	24-Sep-19	221	4%	6%	490	2.8E-07
NT-61	25-Sep-19	226	4%	6%	690	3.9E-07
NT-61	10-Oct-19	225	4%	6%	235	9.2E-07
NT-61	11-Oct-19	210	4%	6%	125	4.8E-07
NT-61	15-Oct-19	172	4%	6%	90	7.0E-07
NT-61	16-Oct-19	118	4%	6%	75	8.7E-07

Leaching Reduction by Constituent		
Site Constituent	13-Sep-19	
1 Arsenic	100%	
2 Benzene	NE; not detected	
3 Toluene	NE; not detected	
4 Ethylbenzene	NE; not detected	
5 Total Xylenes	NE; not detected	
6 Naphthalene	NE; not detected	
7 Acenaphthene	NE; not detected	
8 Acenaphthylene	NE; not detected	
9 Anthracene	NE; not detected	
10 Benzo(a)anthracene	NE; not detected	
11 Benzo(a)pyrene	NE; not detected	
12 Benzo(b)fluoranthene	NE; not detected	
13 Benzo(g,h,i)perylene	NE; not detected	
14 Benzo(k)fluoranthene	NE; not detected	
15 Chrysene	NE; not detected	
16 Dibenz(a,h)anthracene	NE; not detected	
17 Fluoranthene	NE; not detected	
18 Fluorene	0%	Low baseline; no reduction
19 Indeno(1,2,3-cd)pyrene	NE; not detected	
20 Phenanthrene	0%	Low baseline; no reduction
21 Pyrene	0%	Low baseline; no reduction
Constituents Passing	1 of 4

Note: Mixed areas awaiting EPA inspection indicated with blue shading. Green cells are mixed and have been inspected.

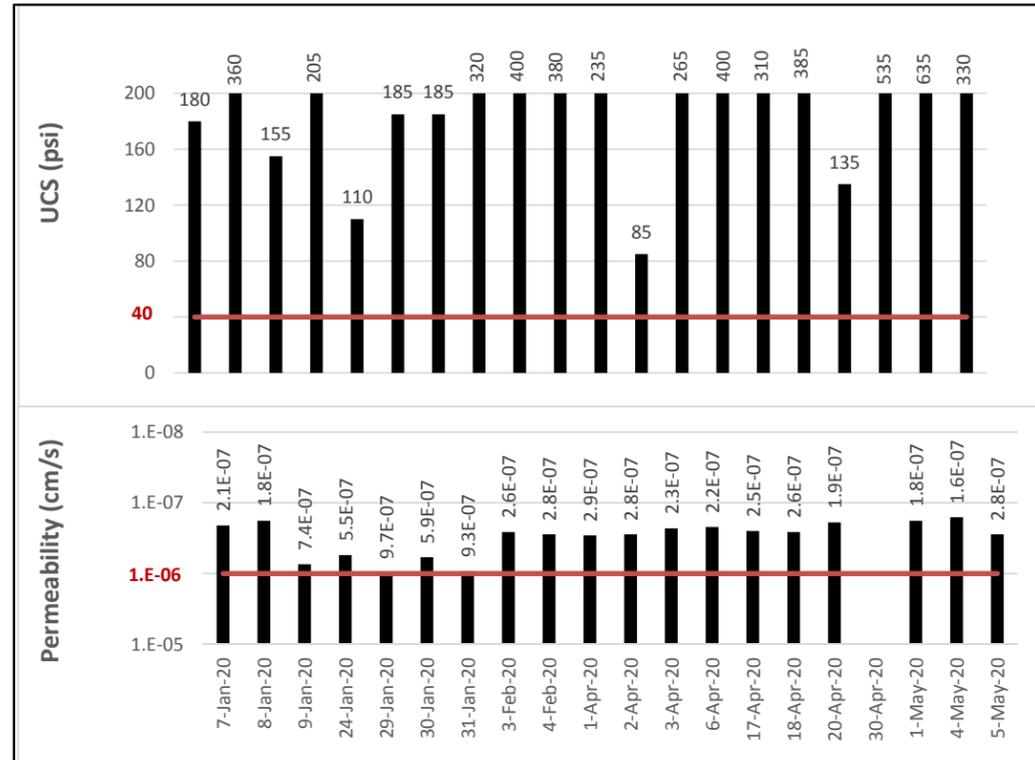
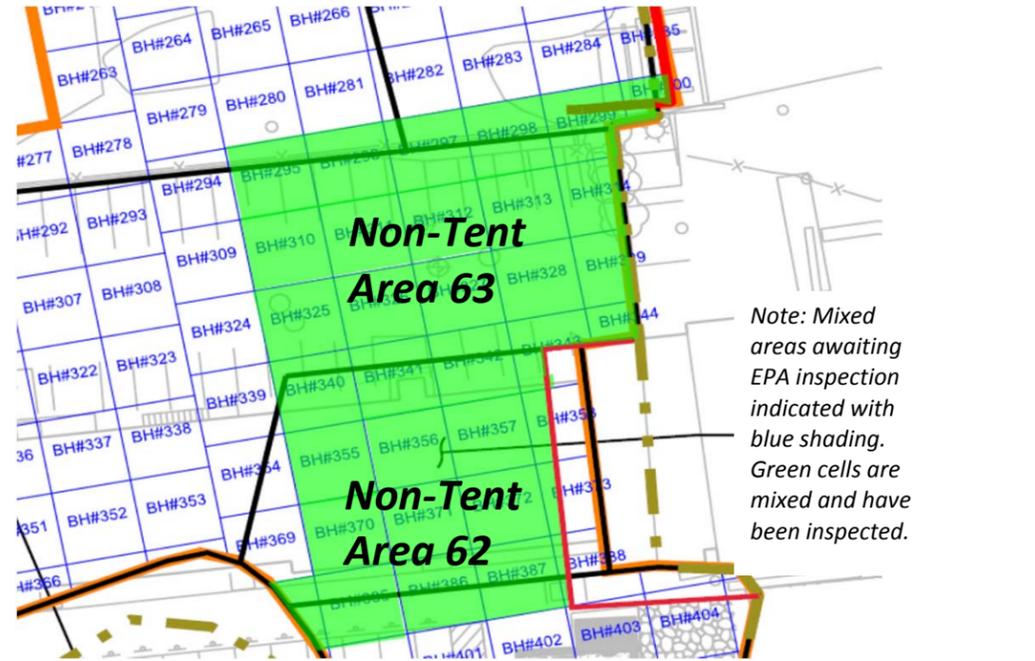
In Situ Solidification/Stabilization Results Dashboard, NT-62/63 (Leaching Batch 7)

Area	Date	Volume (CY)	Mix Design		UCS (≥40 psi)	Permeability (≤1E-6 cm/s)
			Cement	Slag		
NT-62	7-Jan-20	236	4%	6%	180	2.1E-07
NT-62	8-Jan-20	188	4%	6%	360	1.8E-07
NT-62	9-Jan-20	142	4%	6%	155	7.4E-07
NT-62	24-Jan-20	271	4%	6%	205	5.5E-07
NT-62	29-Jan-20	206	4%	6%	110	9.7E-07
NT-62	30-Jan-20	195	4%	6%	185	5.9E-07
NT-62	31-Jan-20	180	4%	6%	185	9.3E-07
NT-62	3-Feb-20	235	4%	6%	320	2.6E-07
NT-62	4-Feb-20	170	4%	6%	400	2.8E-07
NT-63	1-Apr-20	225	4%	6%	380	2.9E-07
NT-63	2-Apr-20	187	4%	6%	235	2.8E-07
NT-63	3-Apr-20	253	4%	6%	85	2.3E-07
NT-63	6-Apr-20	333	4%	6%	265	2.2E-07
NT-63	17-Apr-20	319	4%	6%	400	2.5E-07
NT-64	18-Apr-20	230	4%	6%	310	2.6E-07
NT-65	20-Apr-20	222	4%	6%	385	1.9E-07
NT-66	30-Apr-20	90	4%	6%	135	
NT-67	1-May-20	296	4%	6%	535	1.8E-07
NT-68	4-May-20	189	4%	6%	635	1.6E-07
NT-69	5-May-20	374	4%	6%	330	2.8E-07

Sample Collected May 5, 2020;
data pending

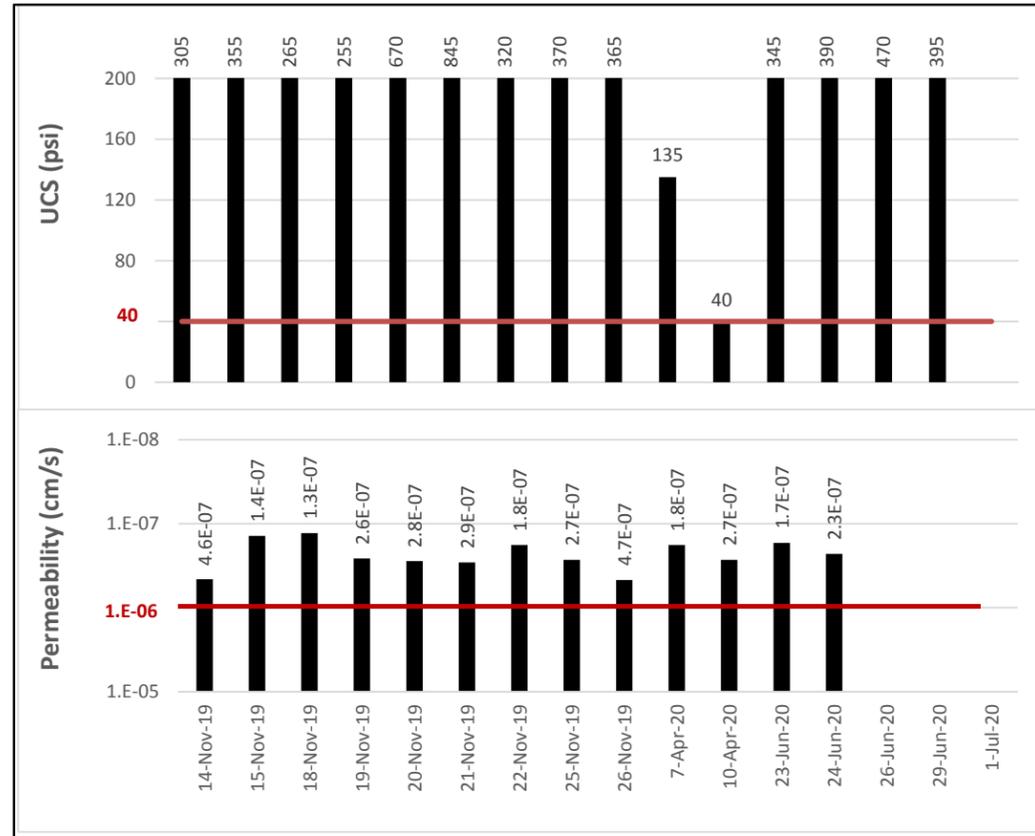
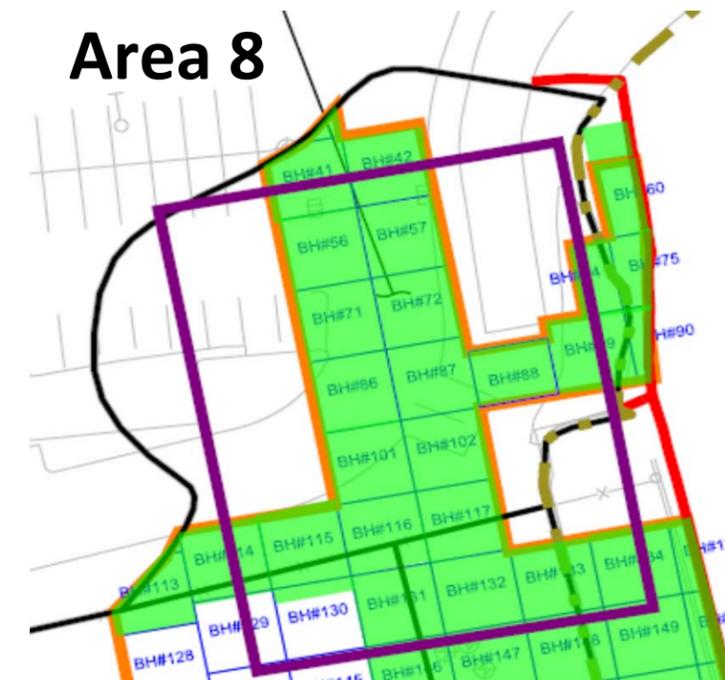
In Situ Solidification/Stabilization Results Dashboard, Area 8 (Leaching Batch 8)

Area	Date	Volume (CY)	Mix Design		UCS (≥40 psi)	Permeability (≤1E-6 cm/s)
			Cement	Slag		
8	14-Nov-19	234	2%	6%	305	4.6E-07
8	15-Nov-19	115	2%	6%	355	1.4E-07
8	18-Nov-19	172	2%	6%	265	1.3E-07
8	19-Nov-19	304	2%	6%	255	2.6E-07
8	20-Nov-19	116	2%	6%	670	2.8E-07
8	21-Nov-19	173	2%	6%	845	2.9E-07
8	22-Nov-19	104	2%	6%	320	1.8E-07
8	25-Nov-19	123	2%	6%	370	2.7E-07
8	26-Nov-19	88	2%	6%	365	4.7E-07
8	7-Apr-20	310	4%	6%	135	1.8E-07
8	10-Apr-20	568	2%	6%	40	2.7E-07
8	23-Jun-20	231	2%	6%	345	1.7E-07
8	24-Jun-20	211	2%	6%	390	2.3E-07
8	26-Jun-20	226	2%	6%	470	
8	29-Jun-20	129	2%	6%	395	
8	1-Jul-20	221	2%	6%

Leaching Reduction by Constituent		
Site Constituent	25-Nov-19	
1 Arsenic	97.19%	
2 Benzene	98.63%	
3 Toluene	97.23%	
4 Ethylbenzene	95.71%	
5 Total Xylenes	95.57%	
6 Naphthalene	95.94%	
7 Acenaphthene	93.38%	
8 Acenaphthylene	NE	<1% tPAH
9 Anthracene	NE	<1% tPAH
10 Benzo(a)anthracene	NE	<1% tPAH
11 Benzo(a)pyrene	NE	Not detected
12 Benzo(b)fluoranthene	NE	Not detected
13 Benzo(g,h,i)perylene	NE	Not detected
14 Benzo(k)fluoranthene	NE	Not detected
15 Chrysene	NE	<1% tPAH
16 Dibenz(a,h)anthracene	NE	Not detected
17 Fluoranthene	NE	<1% tPAH
18 Fluorene	NE	<1% tPAH
19 Indeno(1,2,3-cd)pyrene	NE	Not detected
20 Phenanthrene	NE	<1% tPAH
21 Pyrene	NE	<1% tPAH
Constituents Passing	7 of 7

Note: Mixed areas awaiting EPA inspection indicated with blue shading. Green cells are mixed and have been
