Subject: Quanta Resources Corporation Superfund Site, Operable Unit 1 (OU1), Edgewater, New Jersey, Progress Report: July 2020

This letter is the progress report required pursuant to the U.S. Environmental Protection Agency (EPA) Consent Decree for the Remedial Design (RD) and Remedial Action (RA) at the Quanta Resources Corporation Superfund Site, OU1, which was finalized with the courts on March 11, 2013.

Attachment – Figure 1 - ISS Status Map
In Situ Solidification/Stabilization Results Dashboard

JACOBS
 CIVIL
 PHASE 2 ISS CELLS

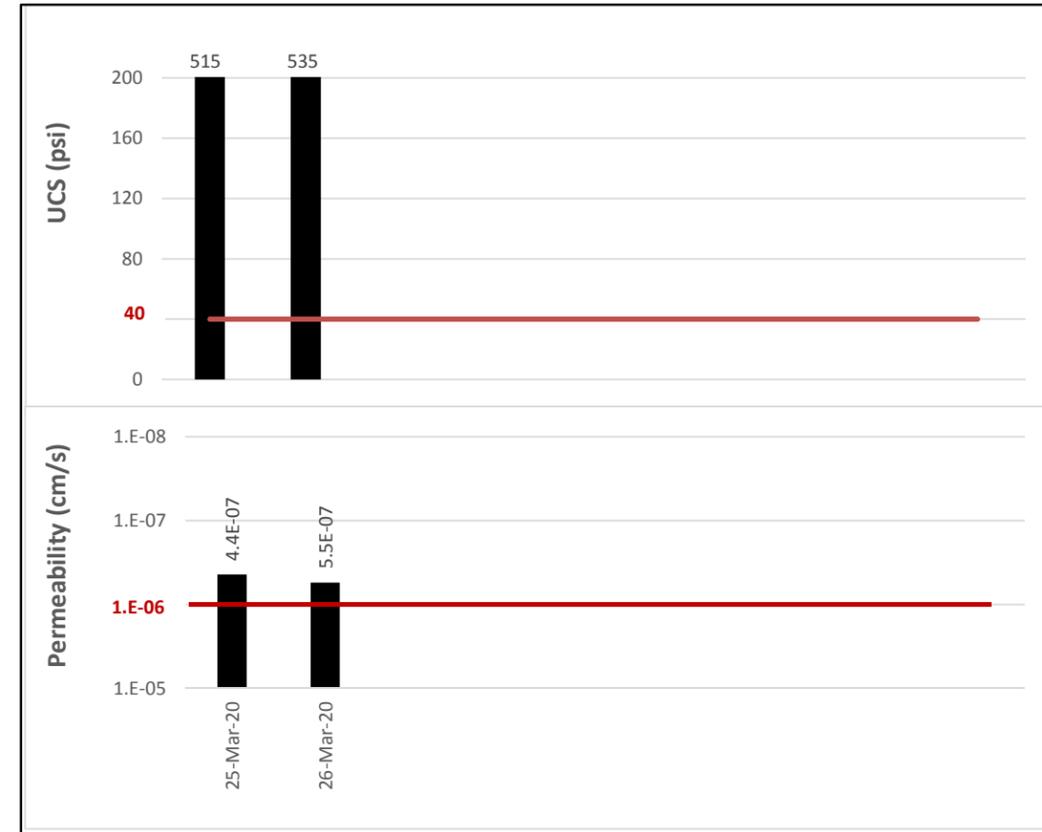
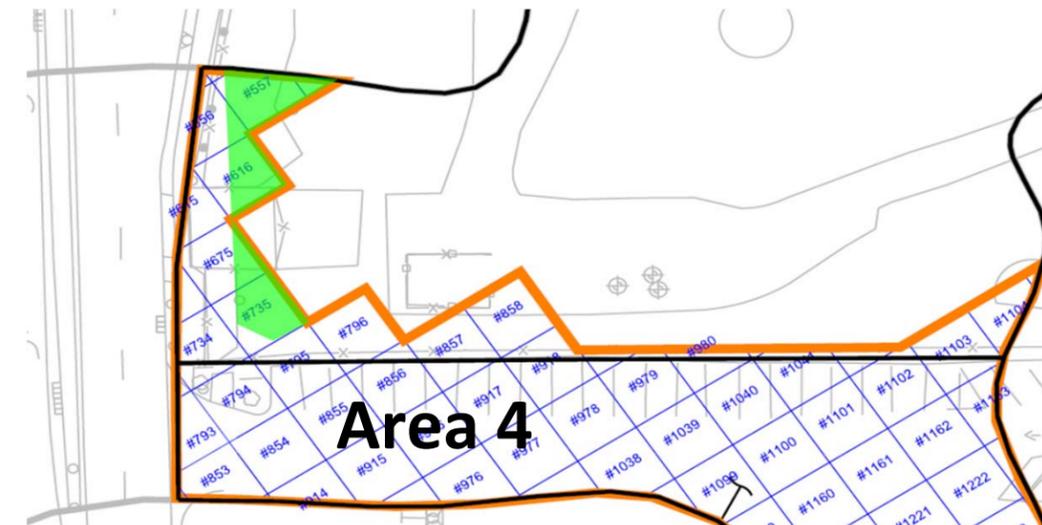
In Situ Solidification/Stabilization Results Dashboard, Area 4 (Leaching Batch 9)

Area	Date	Volume (CY)	Mix Design		UCS (≥ 40 psi)	Permeability ($\leq 1E-6$ cm/s)
			Cement	Slag		
NT-41	25-Mar-20	249	2%	6%	515	4.4E-07
NT-41	26-Mar-20	317	2%	6%	535	5.5E-07

Note: Mixed areas awaiting EPA inspection indicated with blue shading. Green

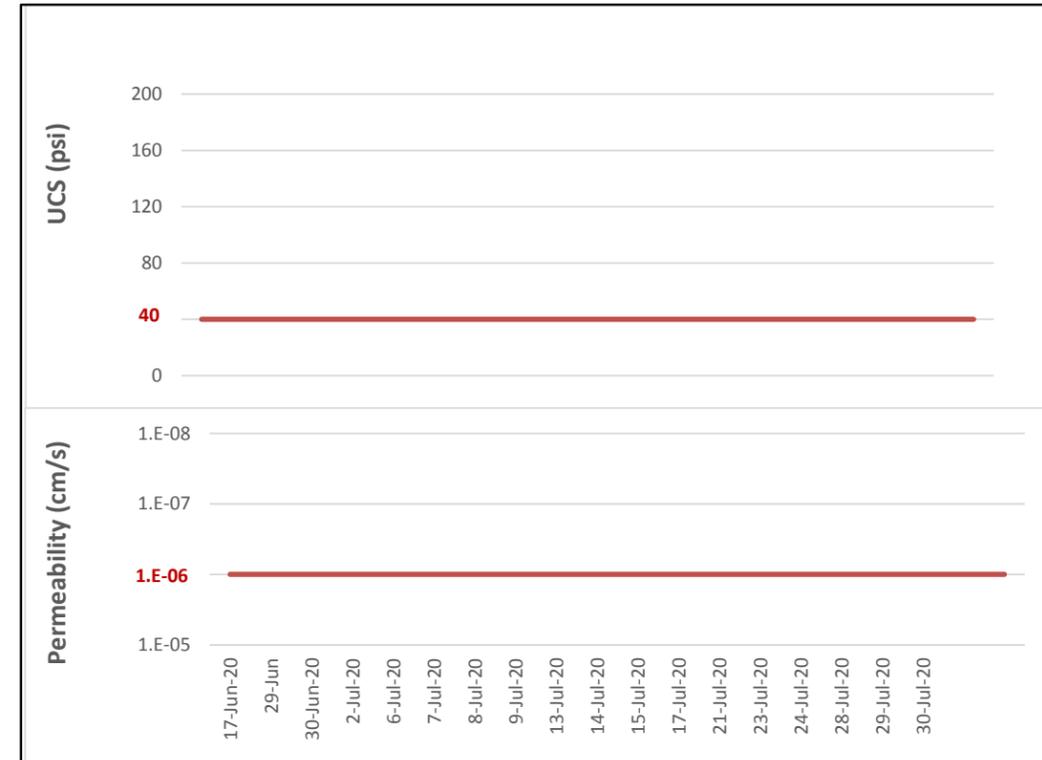
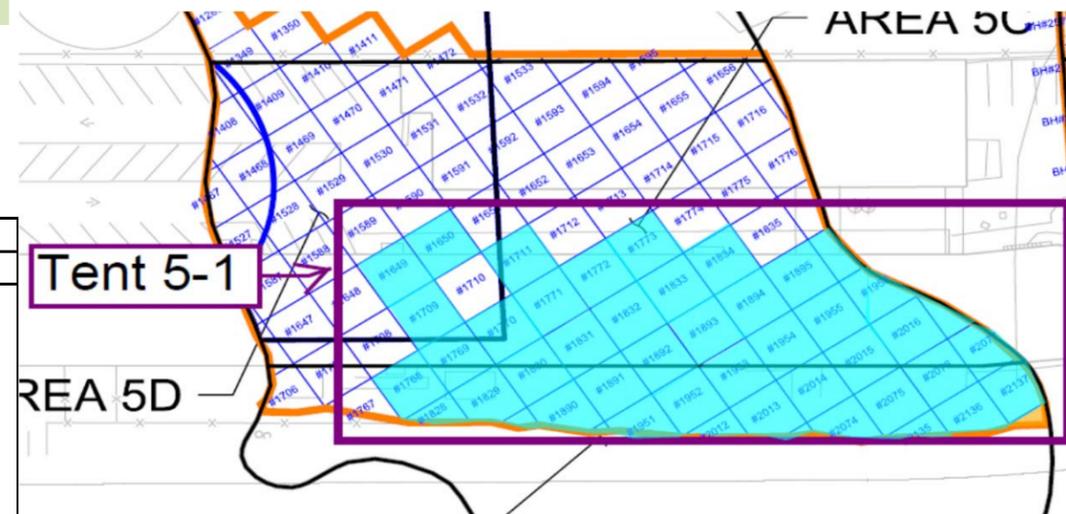
In Situ Solidification/Stabilization Results Dashboard, Tent 5-1 (Leaching Batch 10)

Area	Date	Volume (CY)	Mix Design		UCS (≥40 psi)	Permeability (≤1E-6 cm/s)
			Cement	Slag		
5-1	17-Jun-20	273	2%	6%		
5-1	29-Jun-20	169	2%	6%		
5-1	30-Jun-20	314	2%	6%		
5-1	2-Jul-20	198	2%	6%		
5-1	6-Jul-20	267	2%	6%		
5-1	7-Jul-20	252	2%	6%		
5-1	8-Jul-20	427	2%	6%		
5-1	9-Jul-20	423	2%	6%		
5-1	13-Jul-20	122	2%	6%		
5-1	14-Jul-20	398	2%	6%		
5-1	15-Jul-20	155	2%	6%		
5-1	17-Jul-20	422	2%	6%		
5-1	21-Jul-20	314	2%	6%		
5-1	23-Jul-20	331	4%	6%		
5-1	24-Jul-20	142	2%	6%		
5-1	28-Jul-20	276	4%	6%		
5-1	29-Jul-20	260	4%	6%		
5-1	30-Jul-20	328	2%	6%

Sample Collected July 14, 2020;
sample curing
