**Subject: Quanta Resources Corporation Superfund Site, Operable Unit 1 (OU1), Edgewater, New Jersey, Progress Report: September 2020**

This letter is the progress report required pursuant to the U.S. Environmental Protection Agency (EPA) Consent Decree for the Remedial Design (RD) and Remedial Action (RA) at the Quanta Resources Corporation Superfund Site, OU1, which was finalized with the courts on March 11, 2013.

### In Situ Solidification/Stabilization Results Dashboard, Tent 3-1 (Leaching Batch 5)

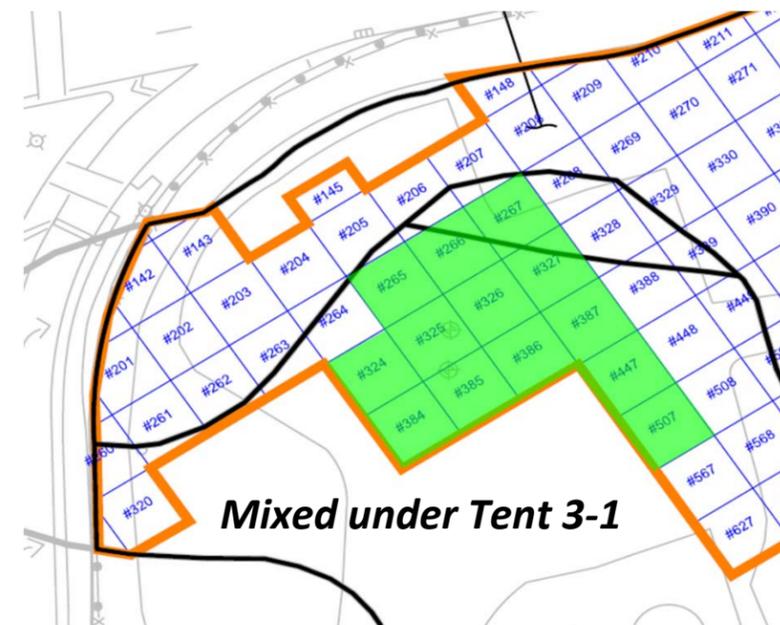
Note: Mixed areas awaiting EPA inspection indicated with blue shading. Green cells are mixed and have been inspected.

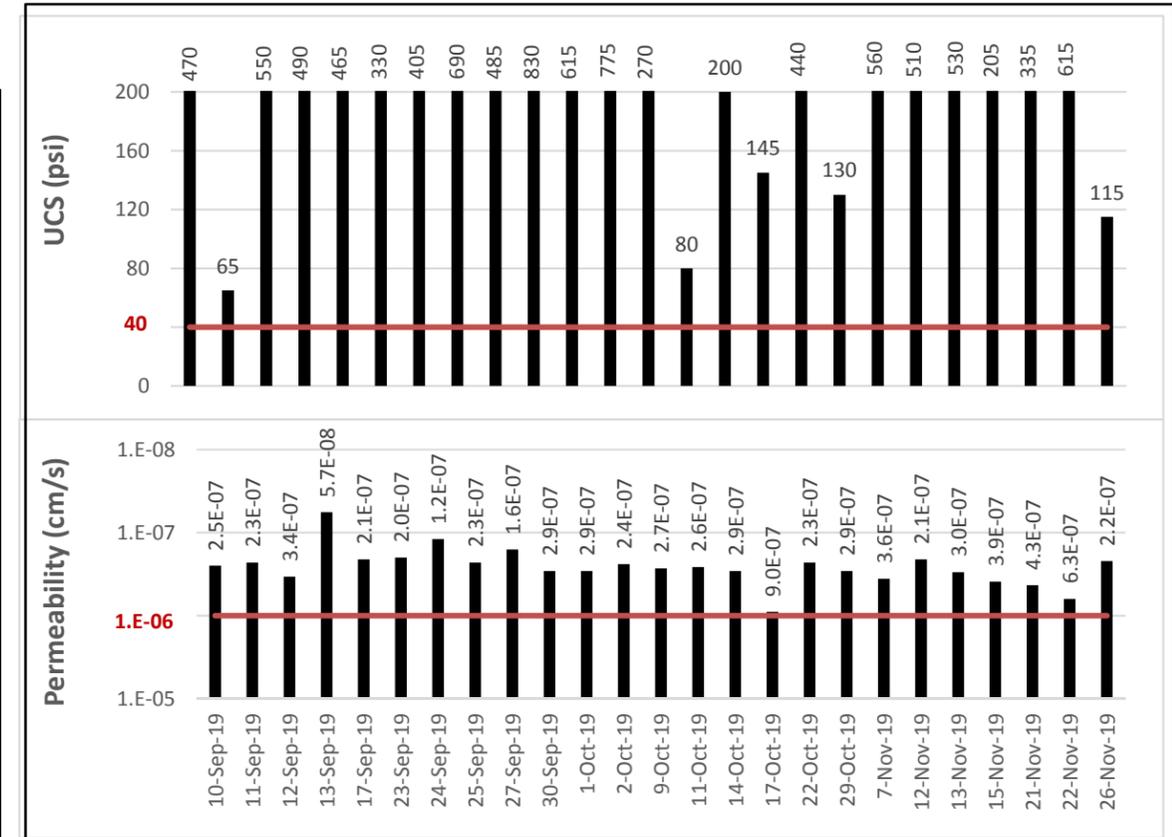
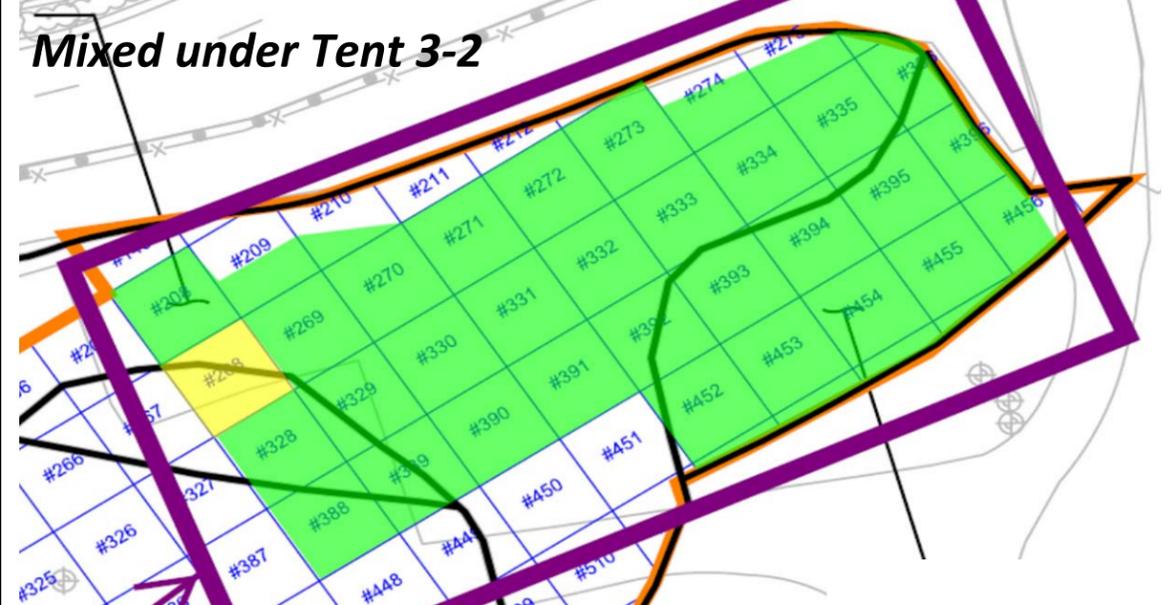
Note: Mixed areas awaiting EPA inspection indicated with blue shading. Green cells are mixed and have been inspected. Yellow cells were previously mixed during the ISS Field Demonstration.

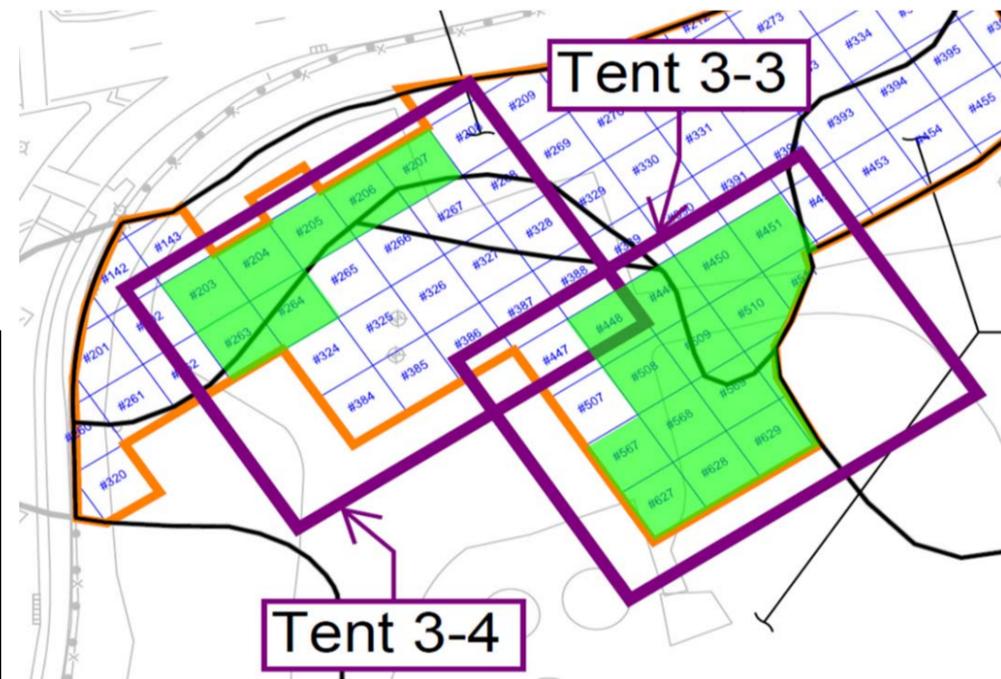
Note: Mixed areas awaiting EPA inspection indicated with blue shading. Green cells are mixed and have been inspected. Yellow cells were previously mixed during the ISS Field Demonstration.

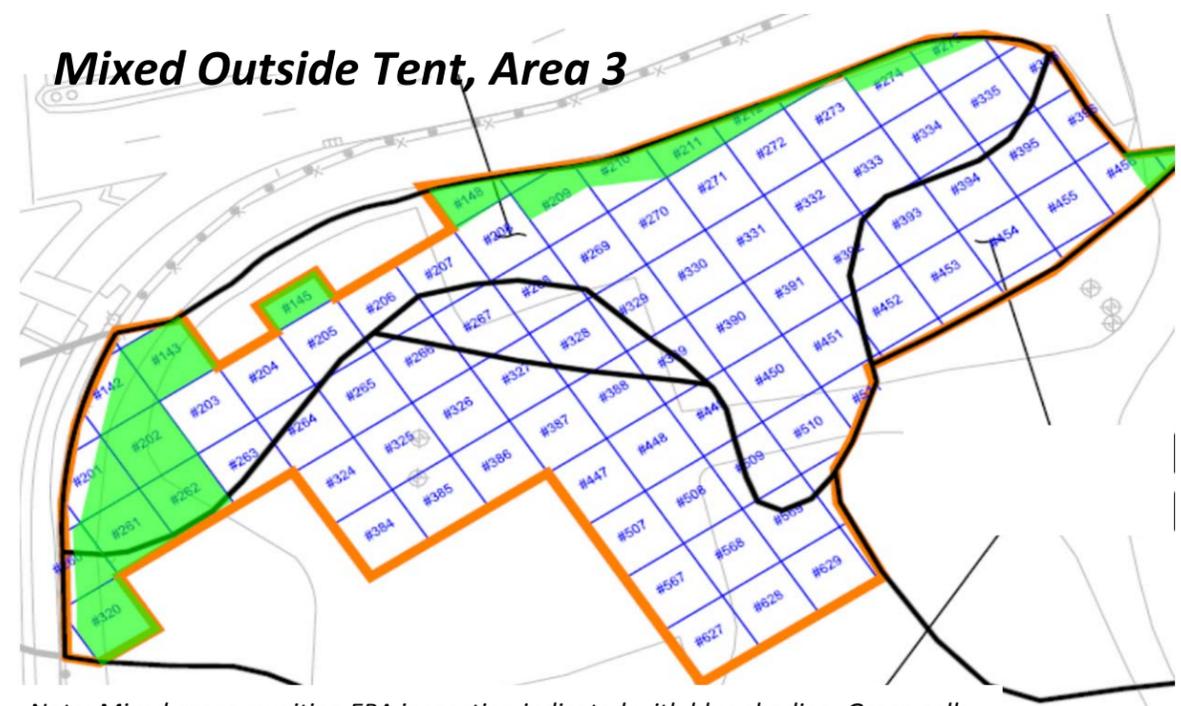
### Mixed Outside Tent, Area 3

Note: Mixed areas awaiting EPA inspection indicated with blue shading. Green cells are mixed and have been inspected. Yellow cells were previously mixed during the ISS Field Demonstration.

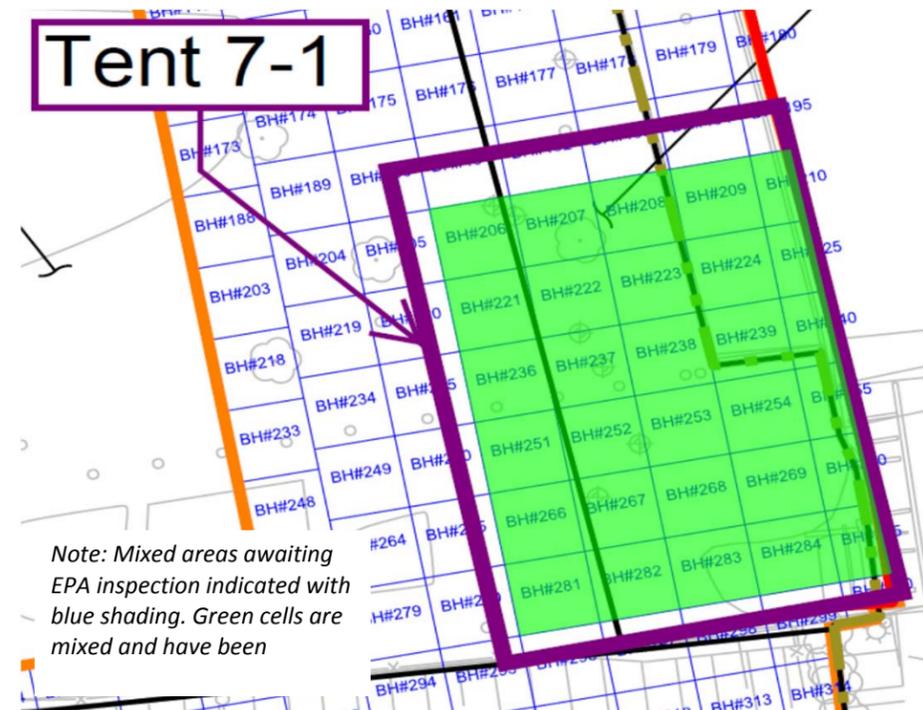
Note: Mixed areas awaiting EPA inspection indicated with blue shading. Green cells are mixed and have been

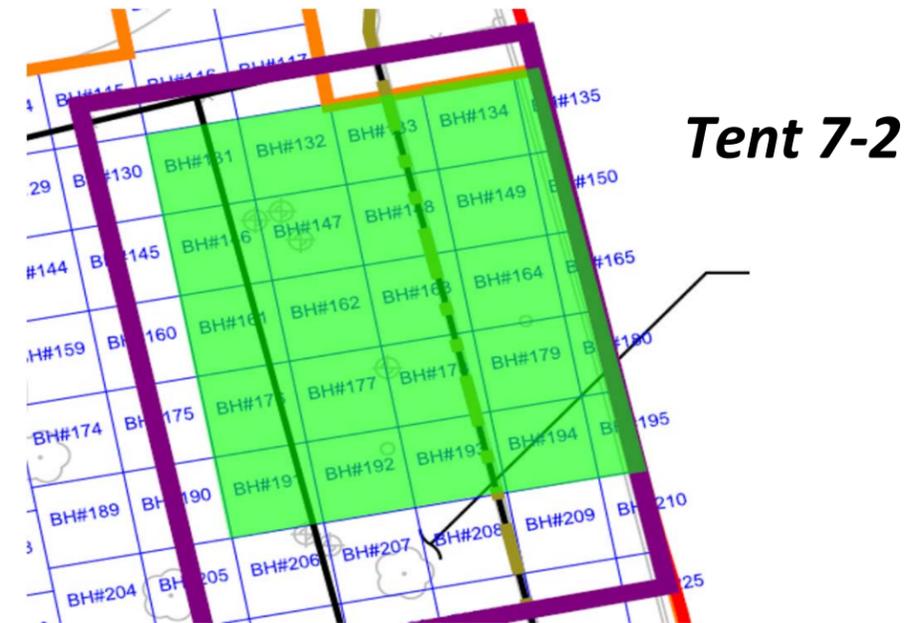
Note: Mixed areas awaiting EPA inspection indicated with blue shading. Green cells are mixed and have been inspected.

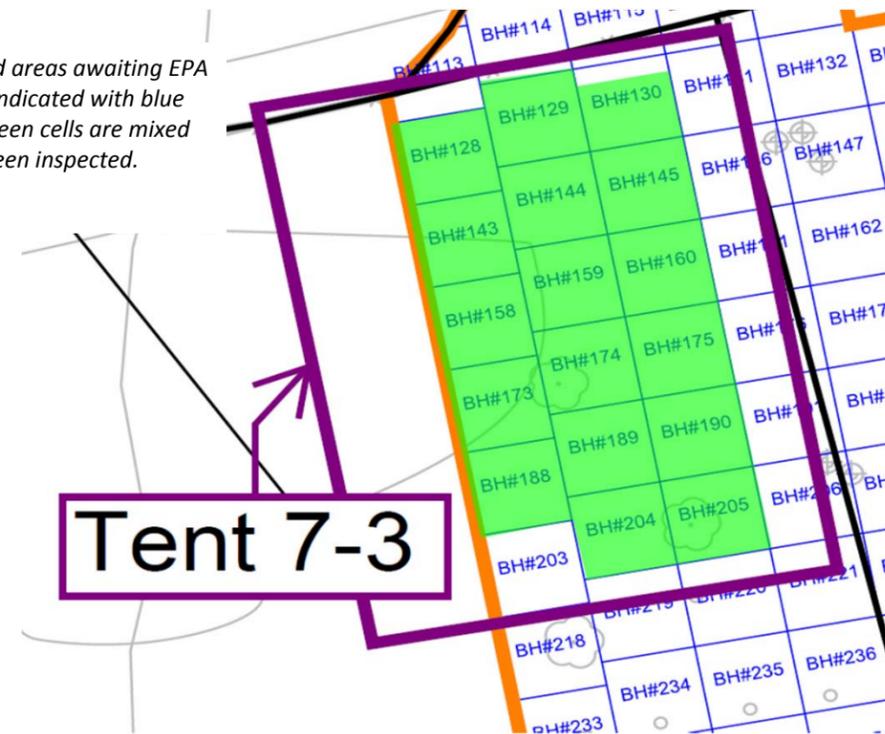
Note: Mixed areas awaiting EPA inspection indicated with blue shading. Green cells are mixed and have been inspected.

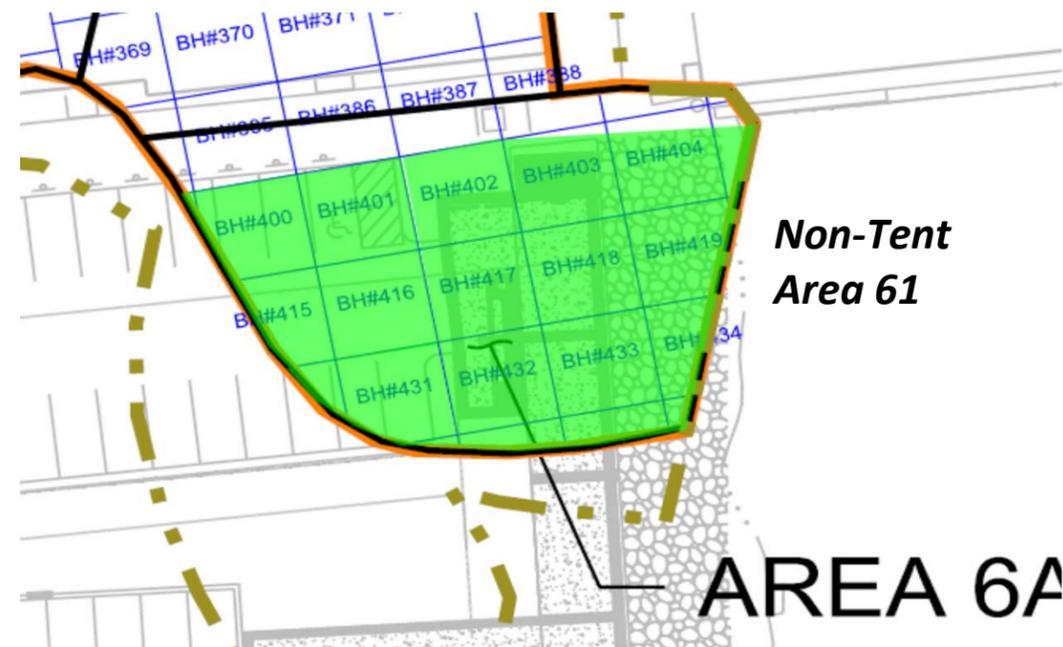
Note: Mixed areas awaiting EPA inspection indicated with blue shading. Green cells are mixed and have been inspected.

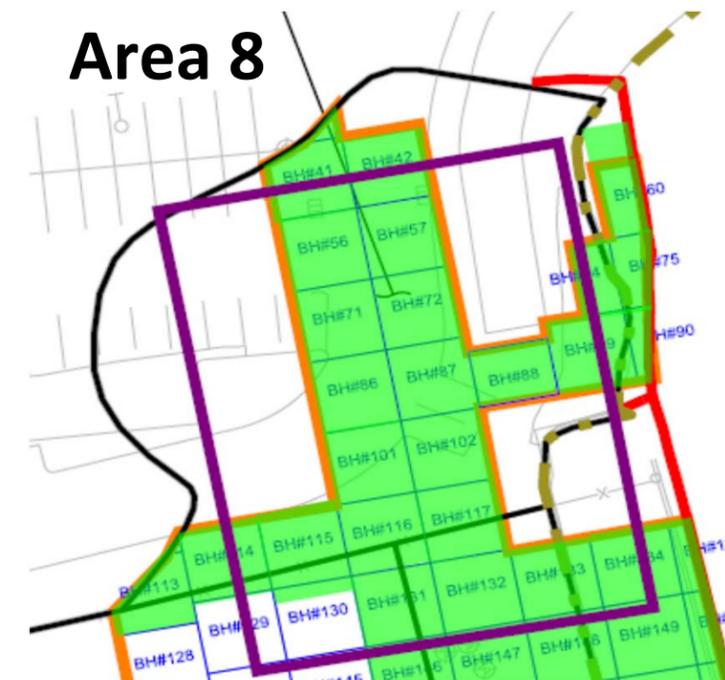
Note: Mixed areas awaiting EPA inspection indicated with blue shading. Green cells are mixed and have been

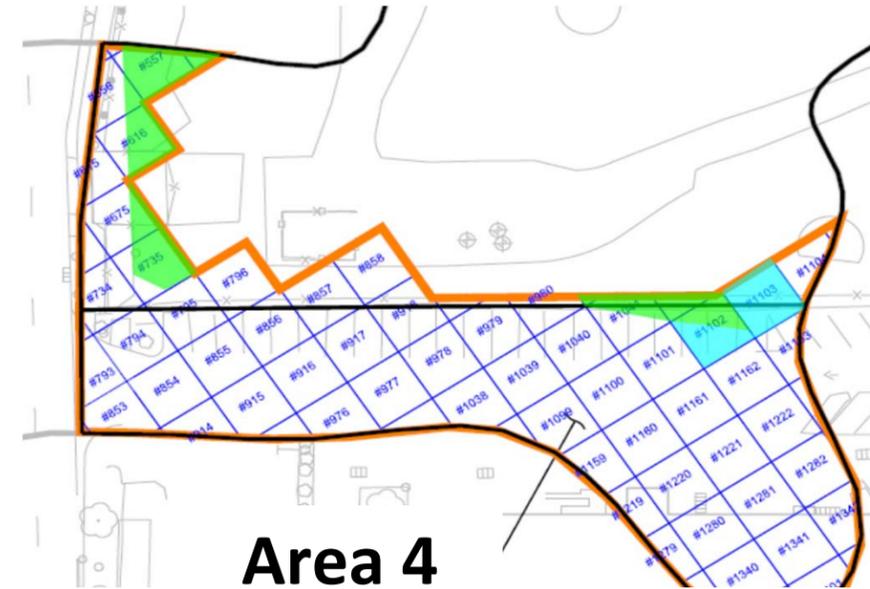
### Area 4

Note: Mixed areas awaiting EPA inspection indicated with blue shading. Green cells are mixed

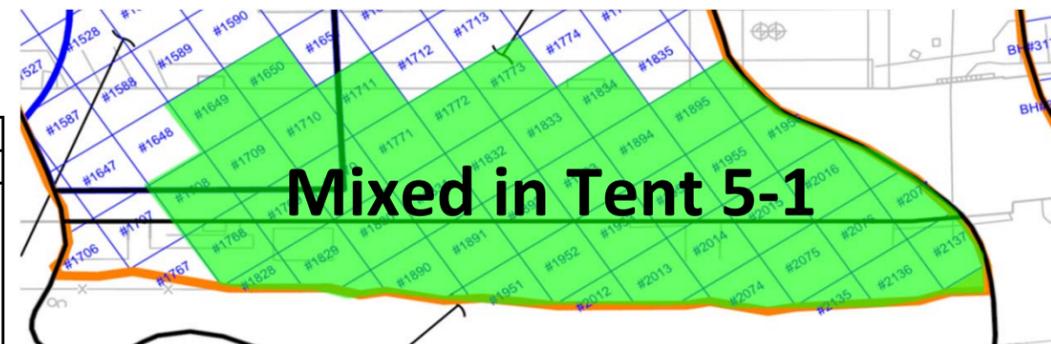
Note: Mixed areas awaiting EPA inspection indicated with blue shading. Green cells are mixed and have been inspected.

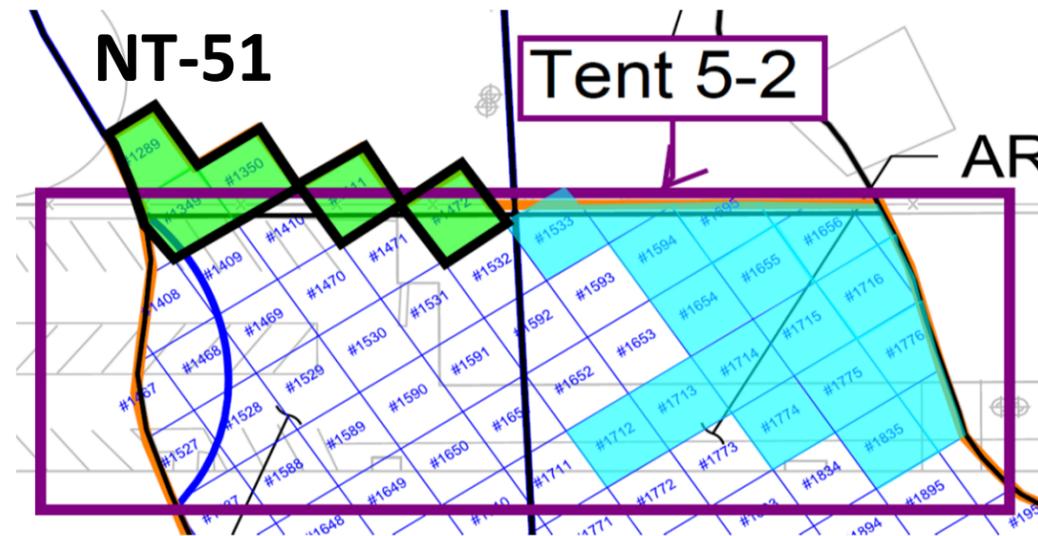
Note: Mixed areas awaiting EPA inspection indicated with blue shading. Green cells are mixed and have been inspected.

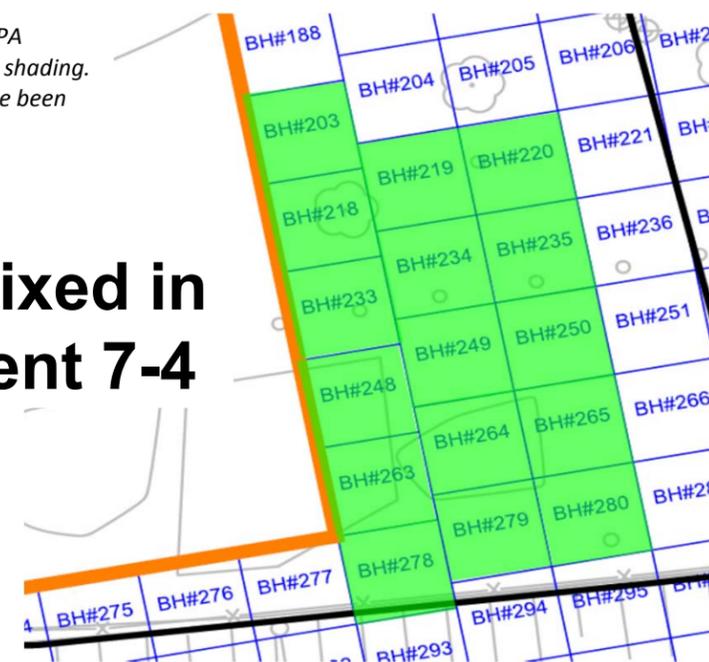
## Mixed in Tent 7-4

Note: Mixed areas awaiting EPA inspection indicated with blue shading. Green cells are mixed and have been inspected.
